# ANNUAL RESERVOIR INSPECTION

HOWELL'S RUN DAM

DEP ID No. D11-103

OCTOBER, 2015

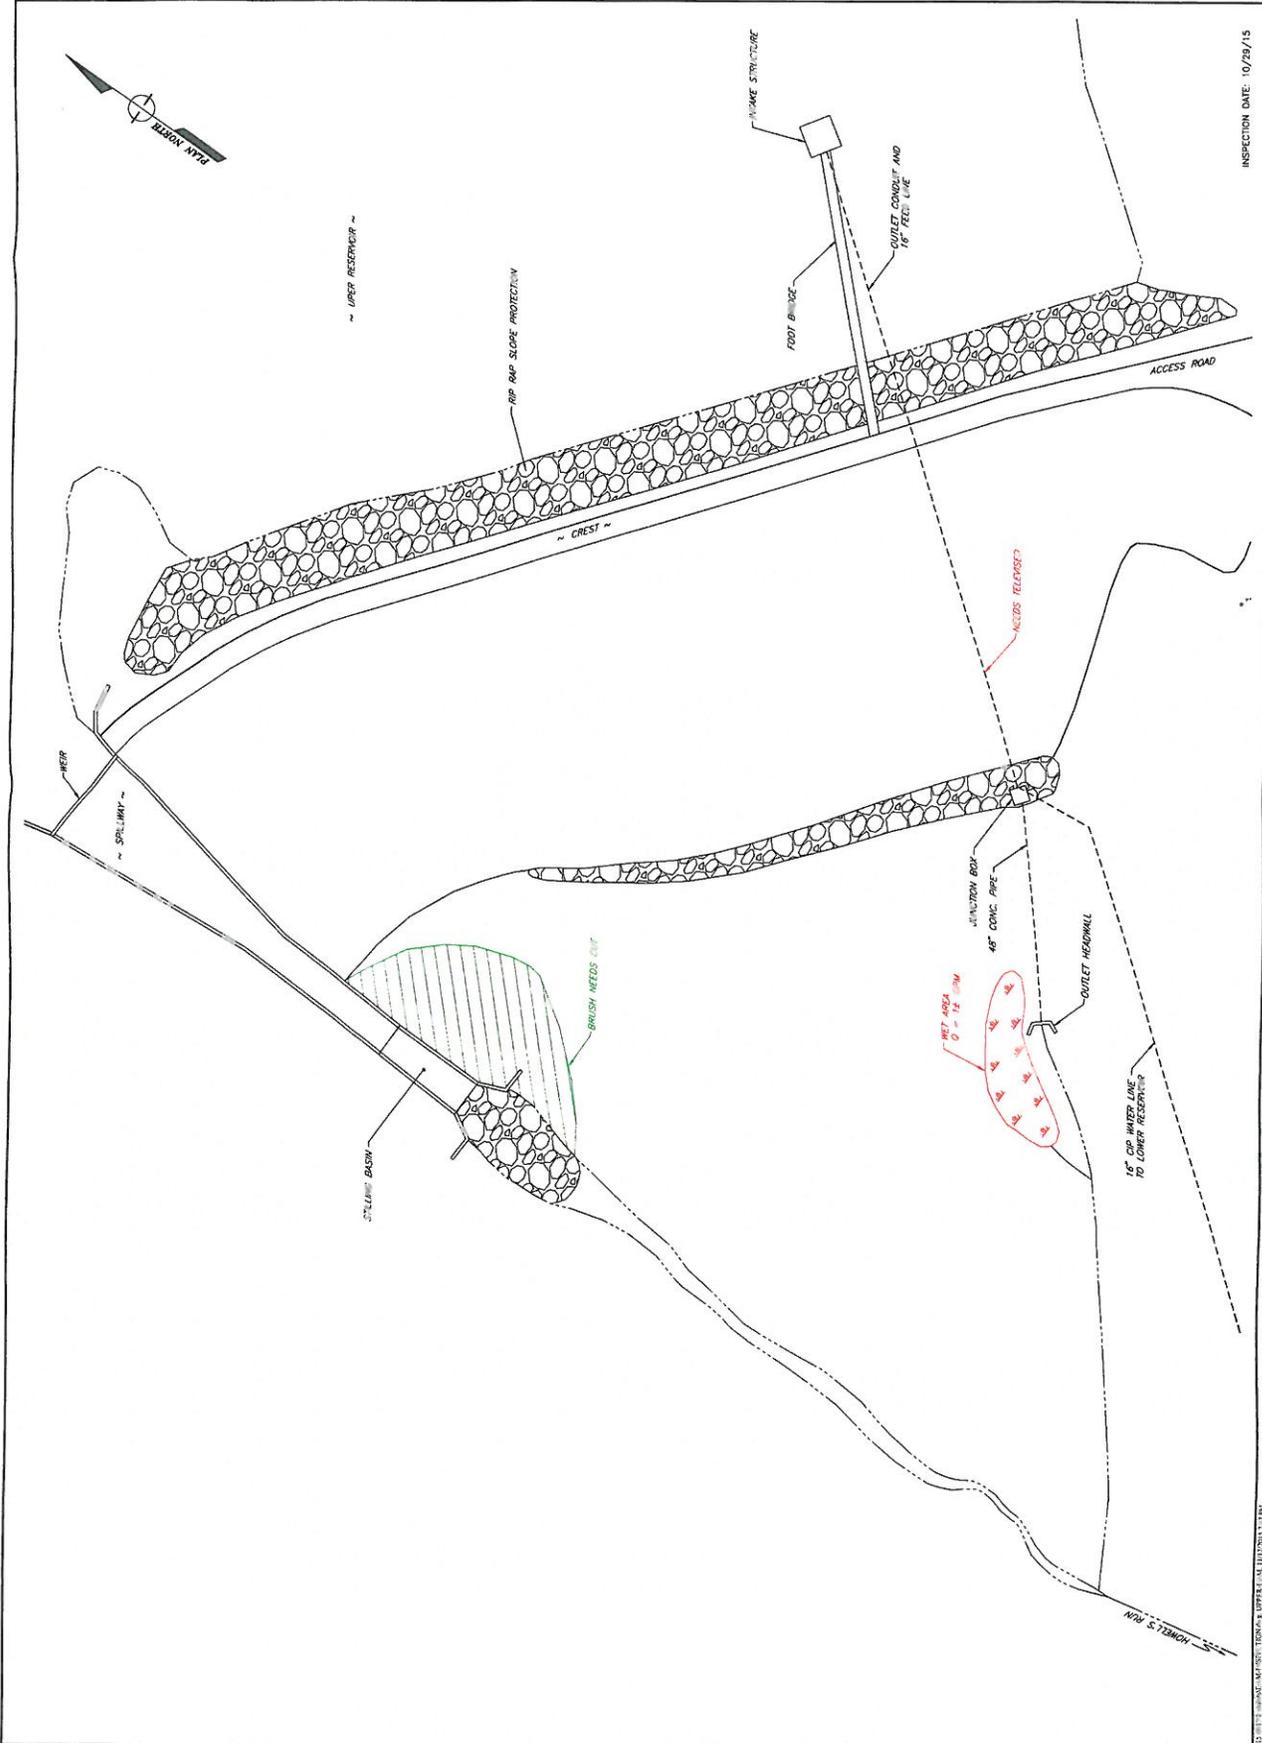
**S2**

1. Vegetative cover on the dam crest and downstream embankment was well maintained. However, an area along the eastern spillway wall is overgrown and should be cut. See the Sketch Plan and Photo 15.
2. Inlet ends of the corrugated steel pipes through the stilling basin wall should be cleared of silt and debris.
3. The weired 6" or 8" pipe extending through the eastern spillway wall was flowing briskly. We understand the source to be an underdrain. The location of this drain should be ascertained and the flow monitored.

5. The area downstream of the embankment toe was very wet. The wettest area is shown on the sketch plan. Flow was observed at the lower end of the wet area and estimated to be approximately 1 GPM. This situation may have been influenced by significant rainfall the days proceeding our inspection. In any case, the flow from this area should be monitored.

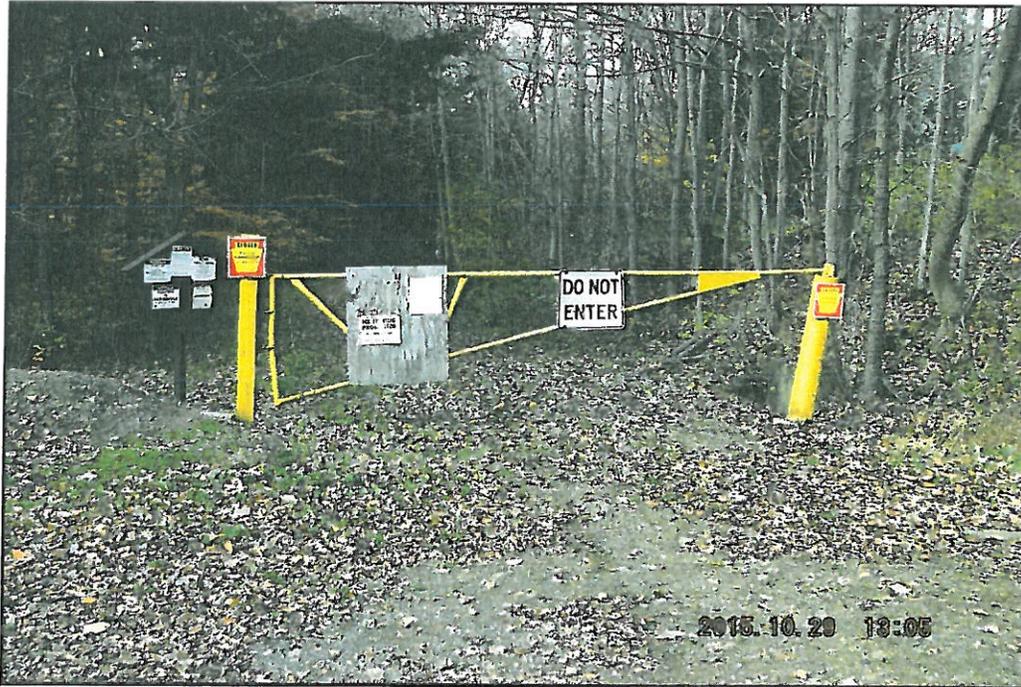
Photo 1: View of Gated Access to Dam

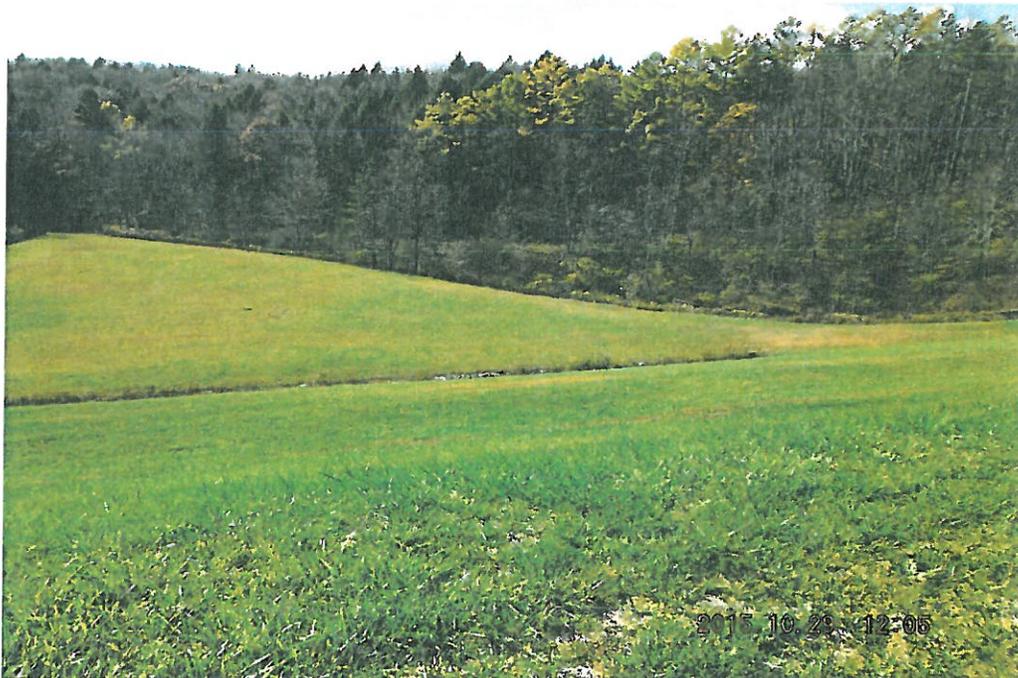
Photo 2: Downstream Embankment Looking Northwest

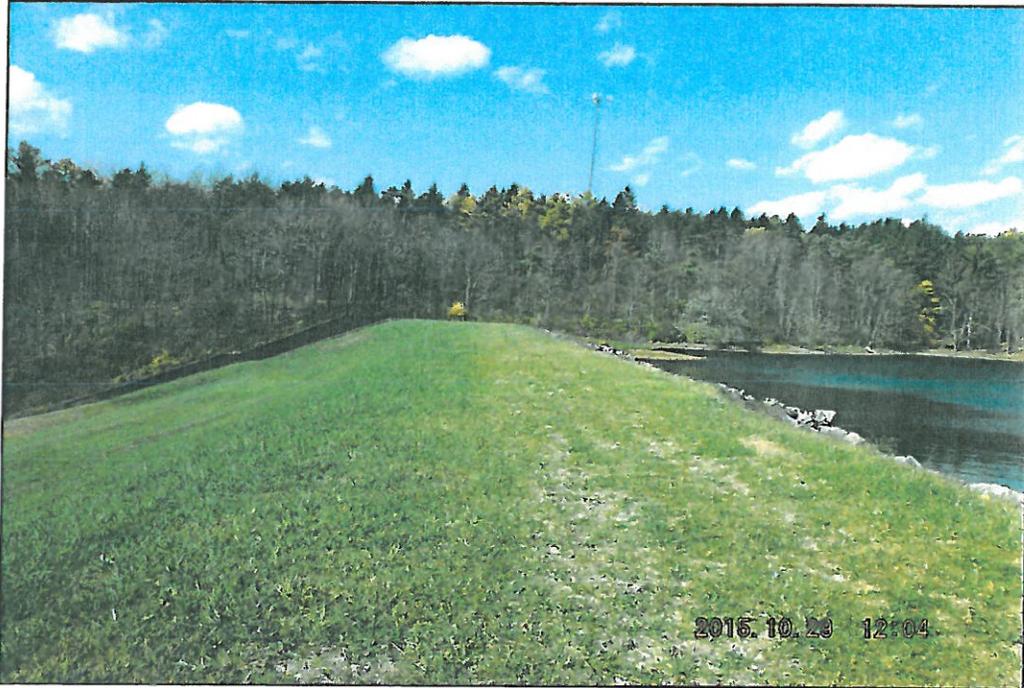
Photo 3: Crest looking Northwest toward Spillway

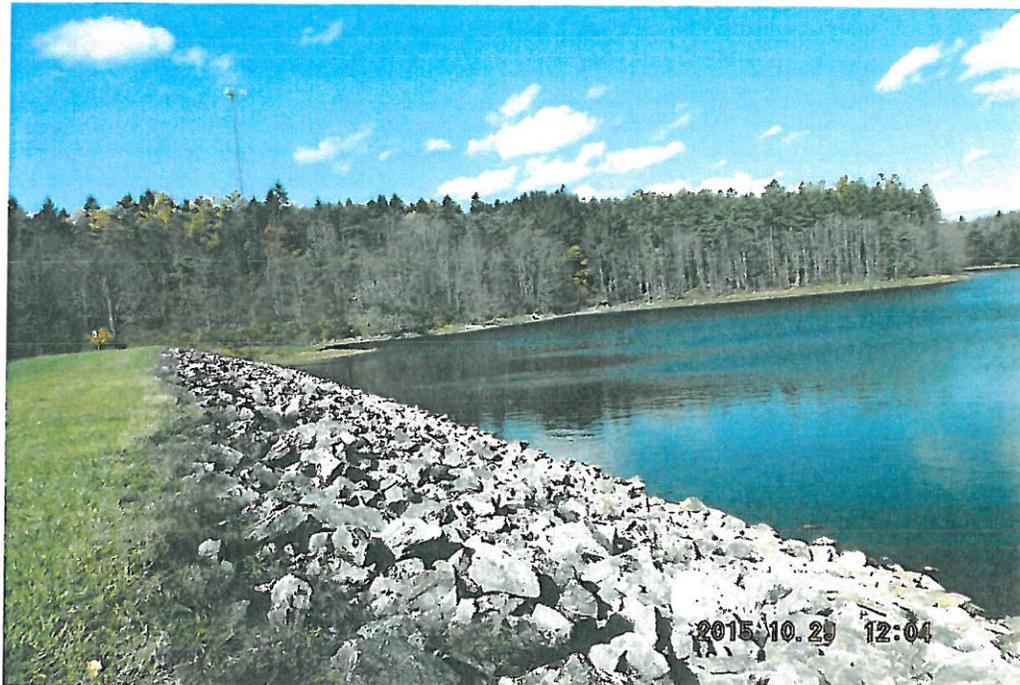
Photo 4: Upstream Embankment looking Northwest

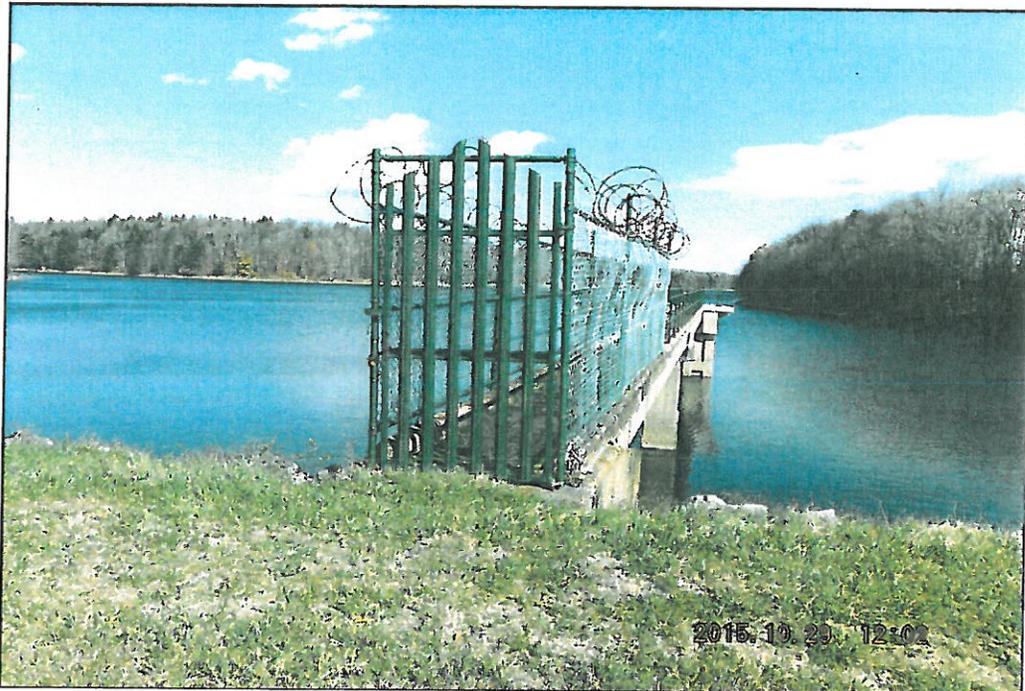
Photo 5: View of Locked Gate Access to the Bridge and Intake Structure

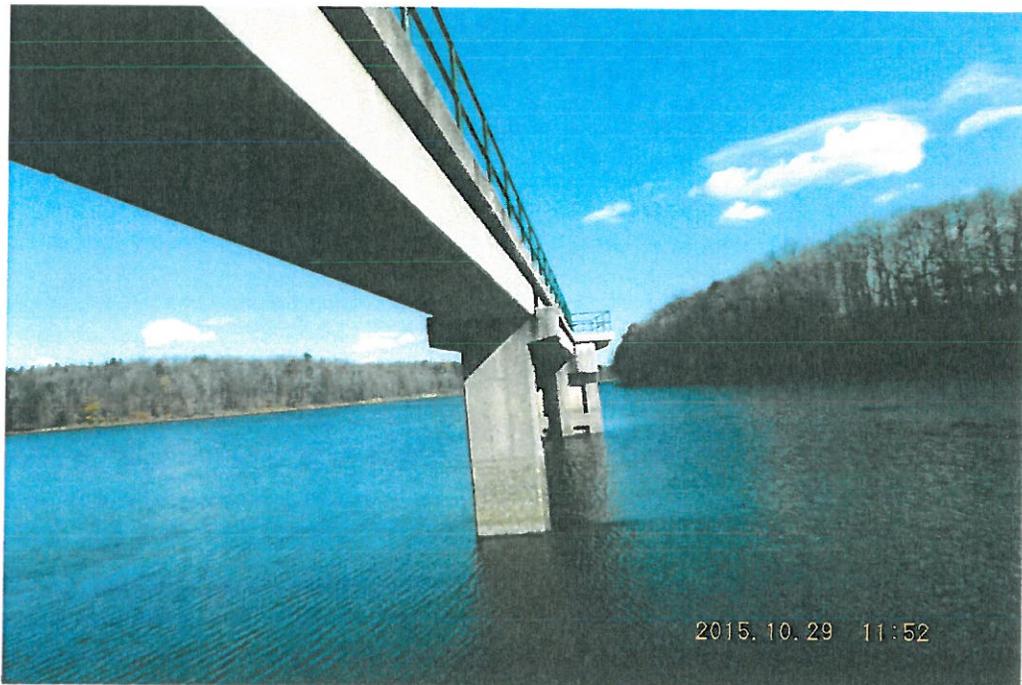
Photo 6: View of Bridge Pier and Staff Gauge

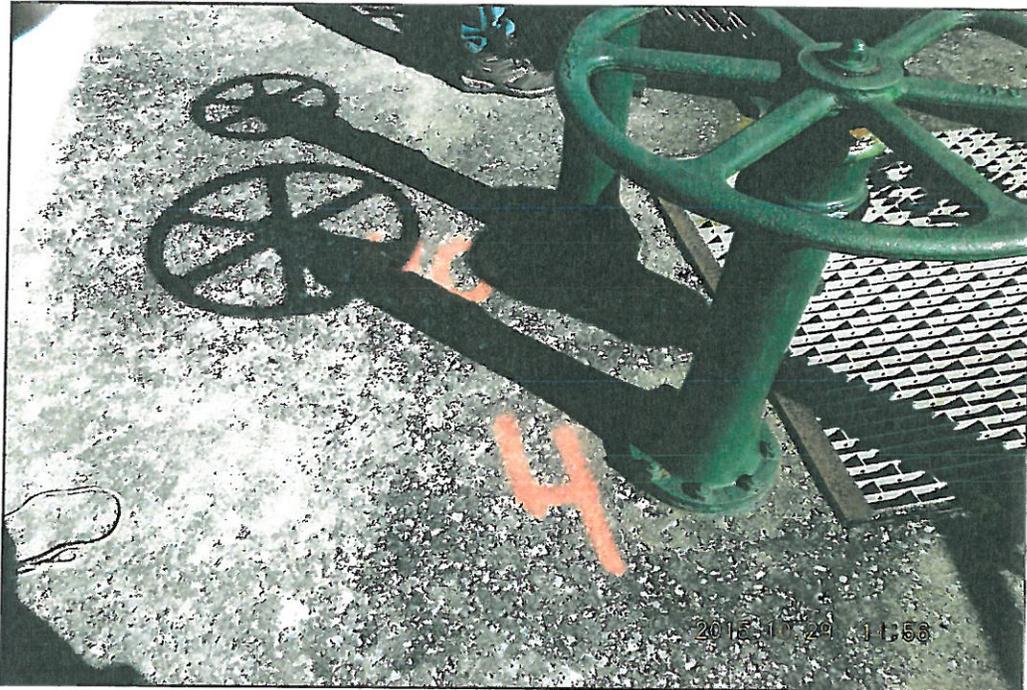
Photo 7: View of Valve Stems at Top of Intake Structure

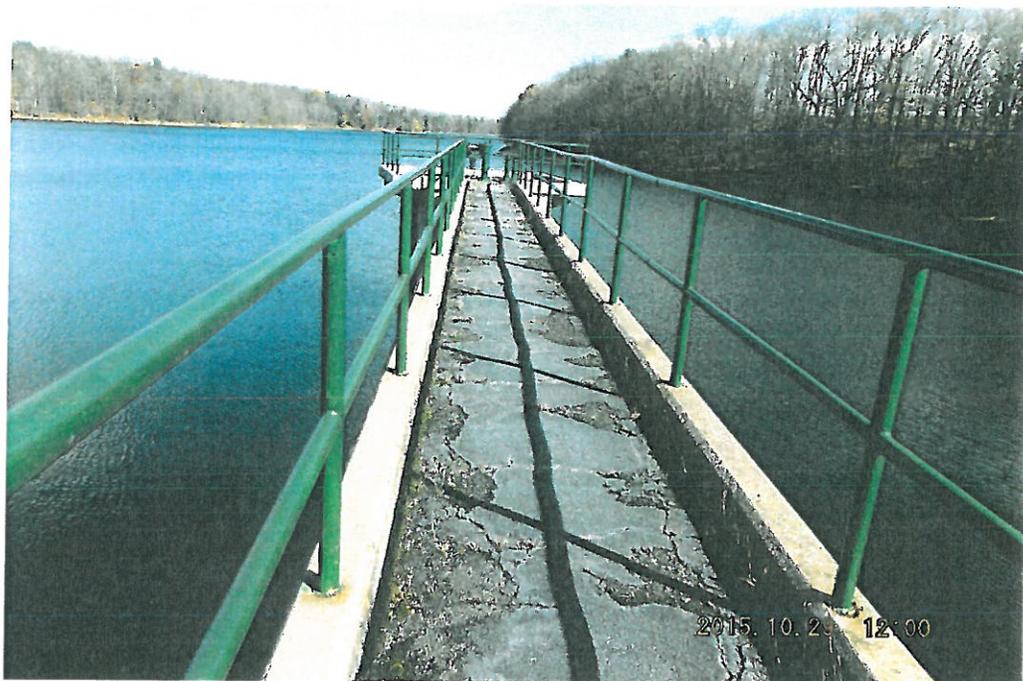
Photo 8: View of Bridge Walkway

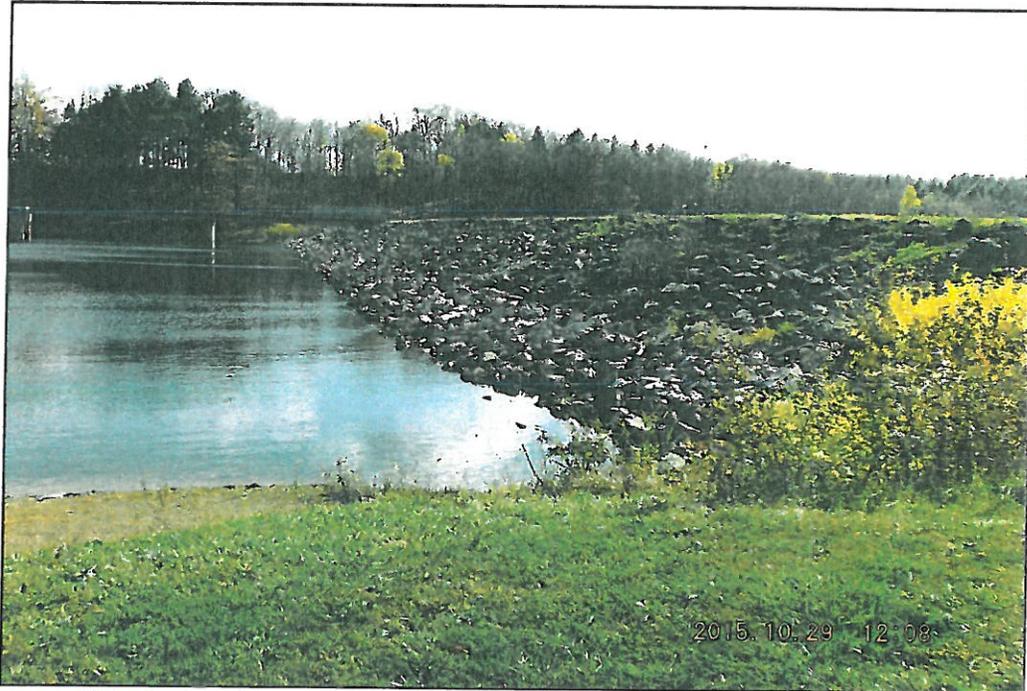
Photo 9: Upstream Embankment Looking Southeast

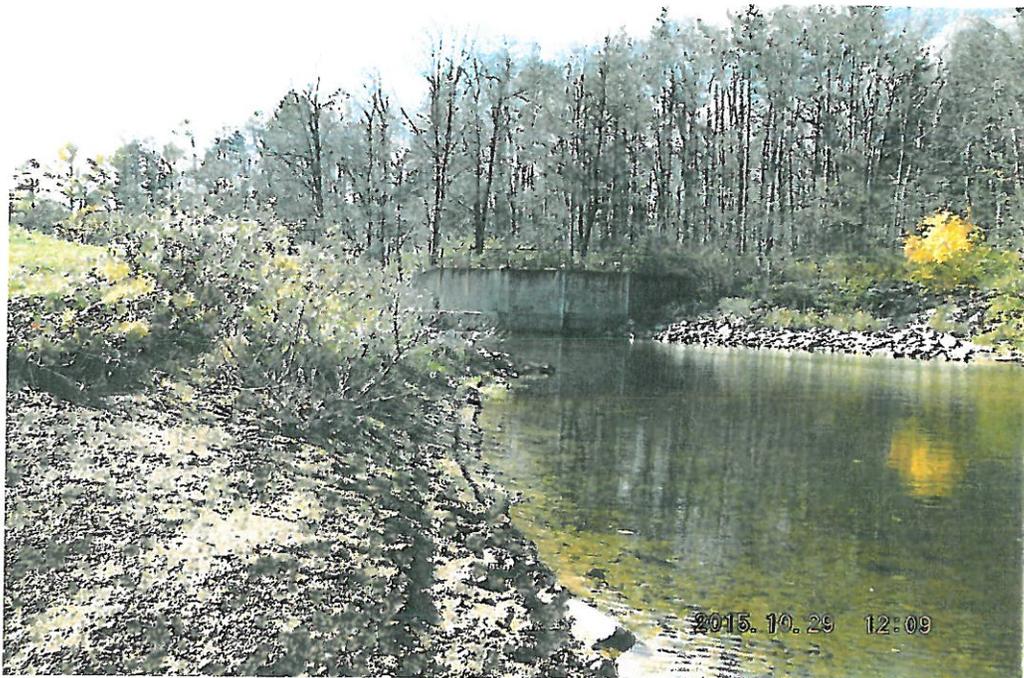
Photo 10: View of Spillway Approach Channel

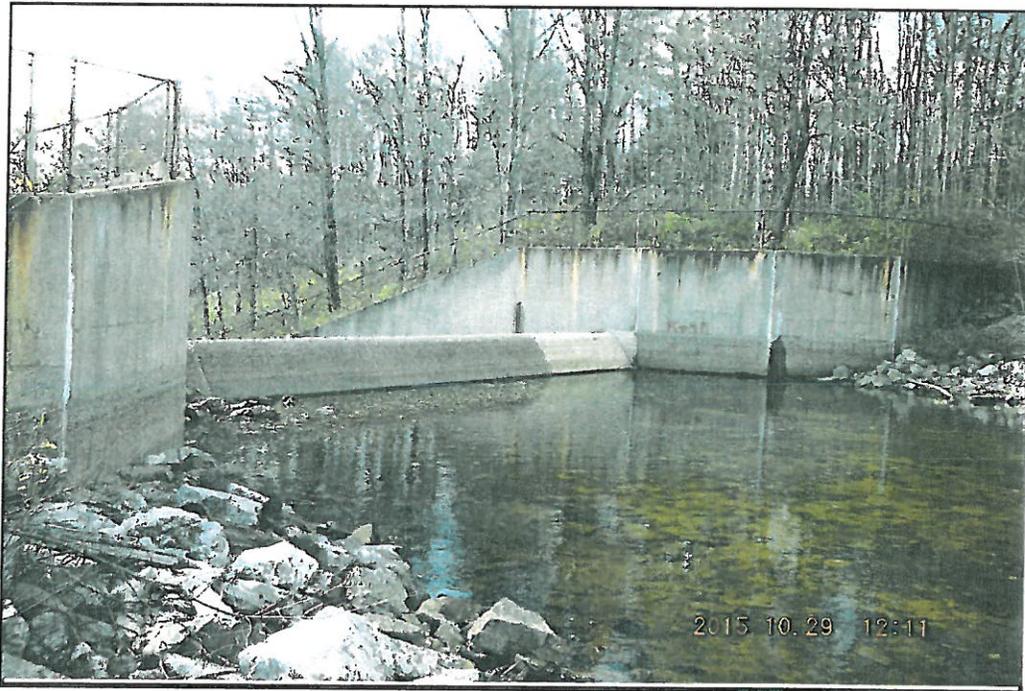
Photo 11: View of Spillway Weir and Walls

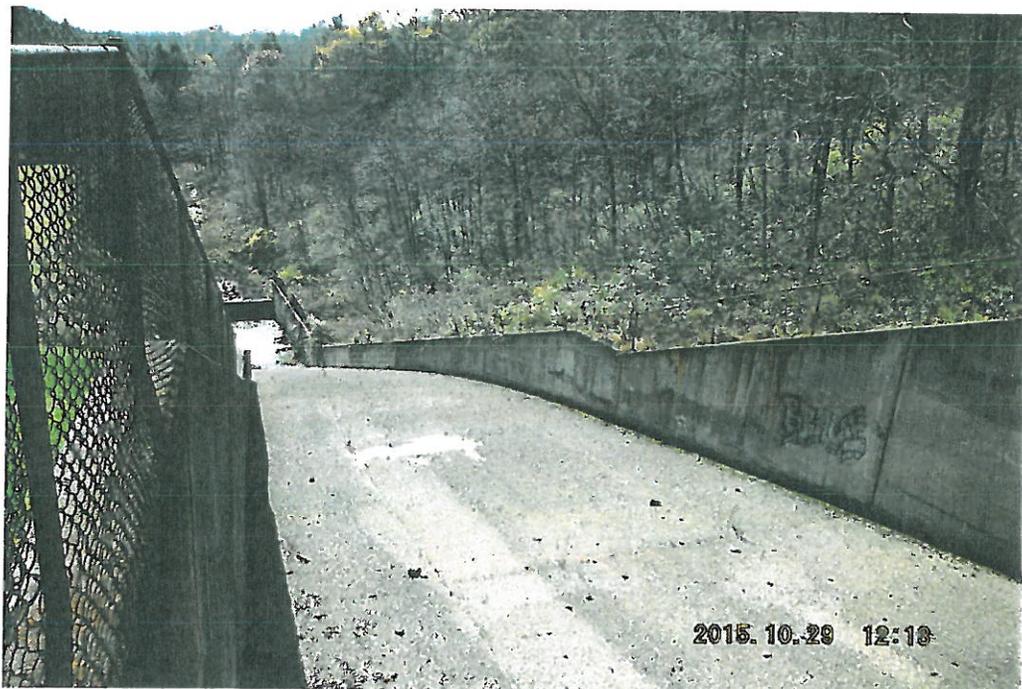
Photo 12: Spillway Channel looking South

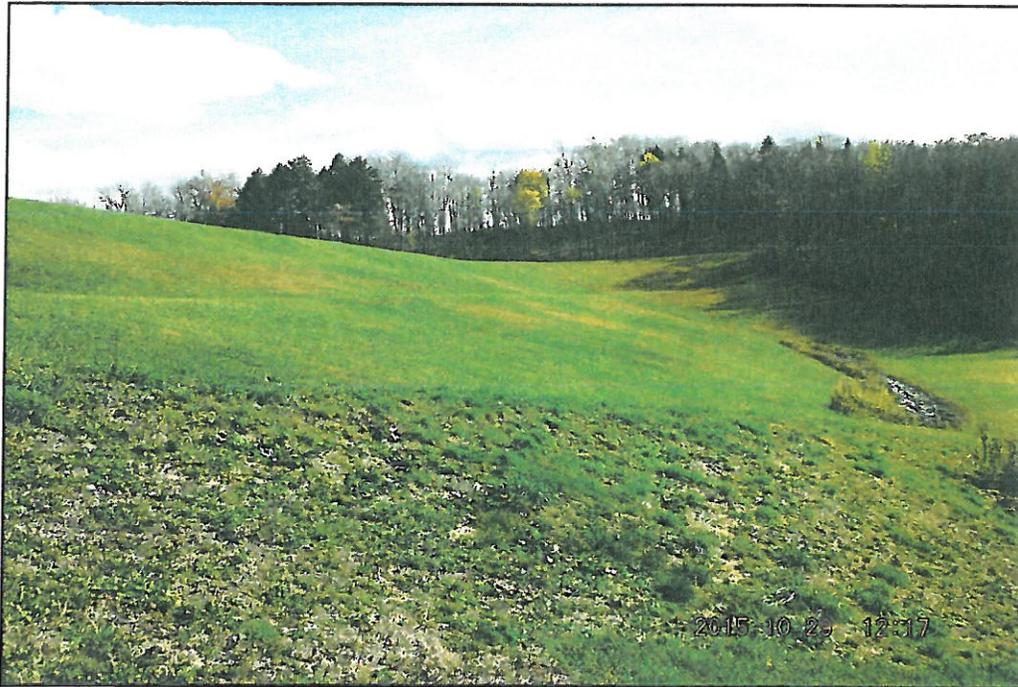
Photo 13: Downstream Embankment looking Southeast

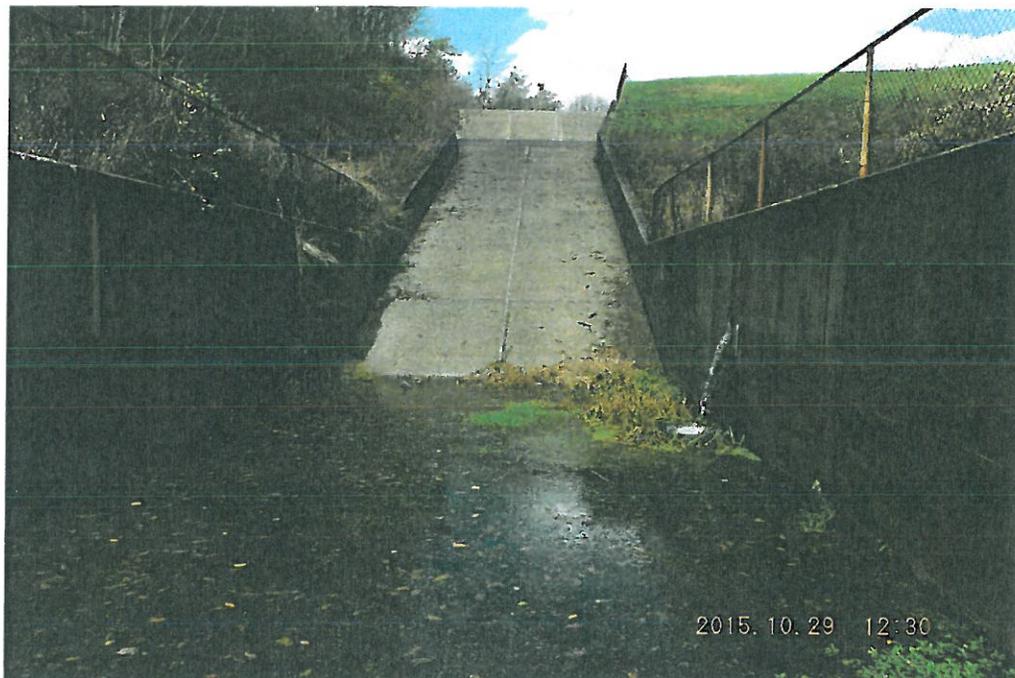
Photo 14: Spillway Channel looking North

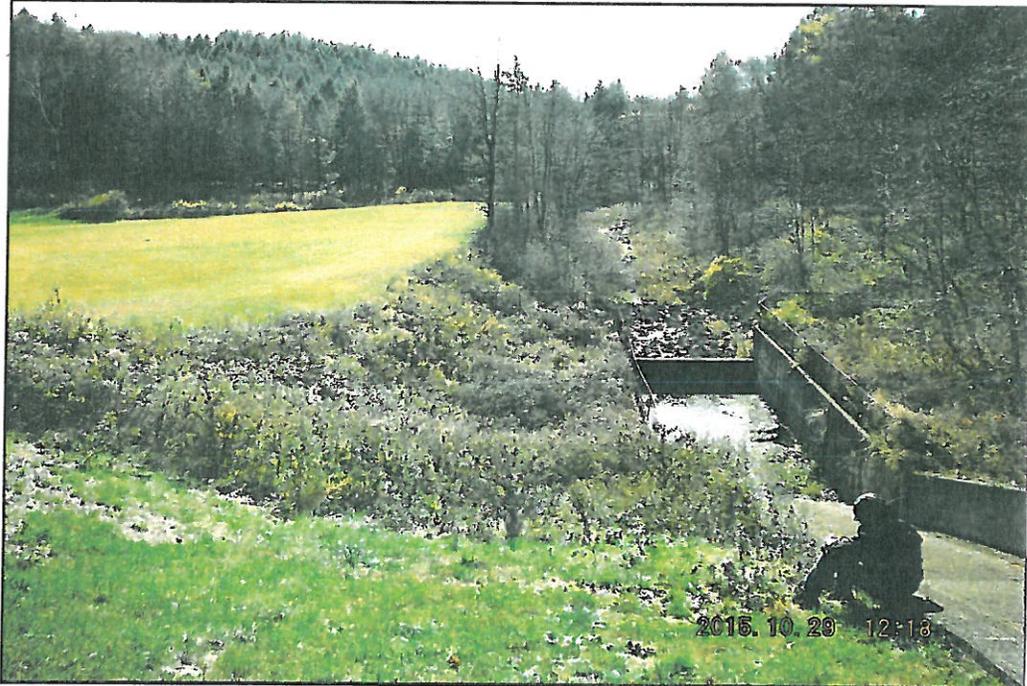
Photo 15: View of Vegetation along Eastern Spillway Wall

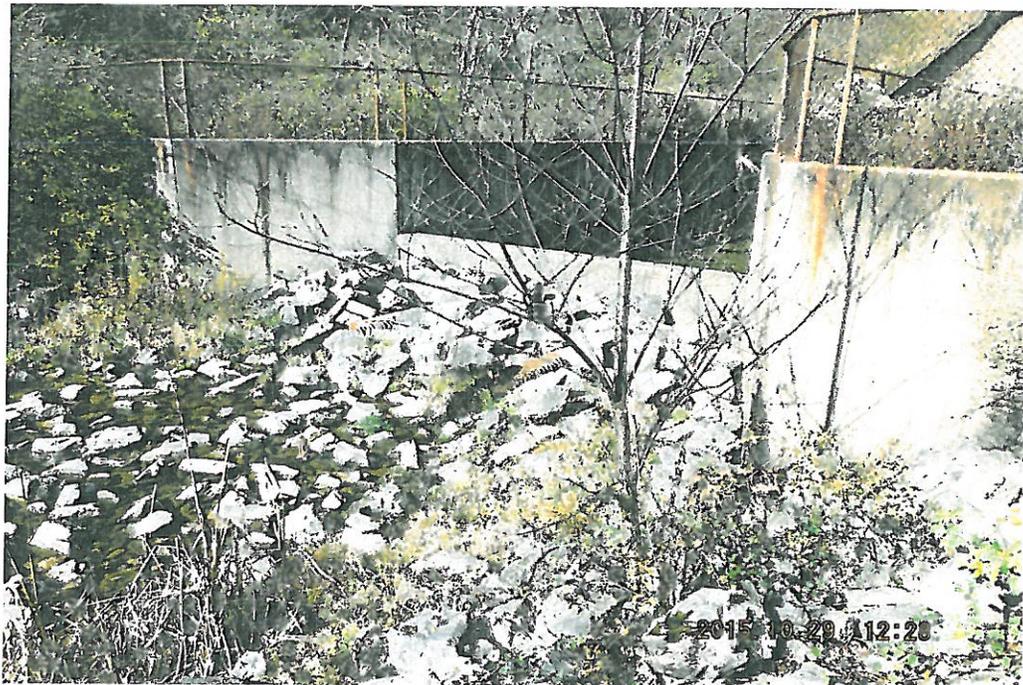
Photo 16: View of Stilling Basin Wall and Weir

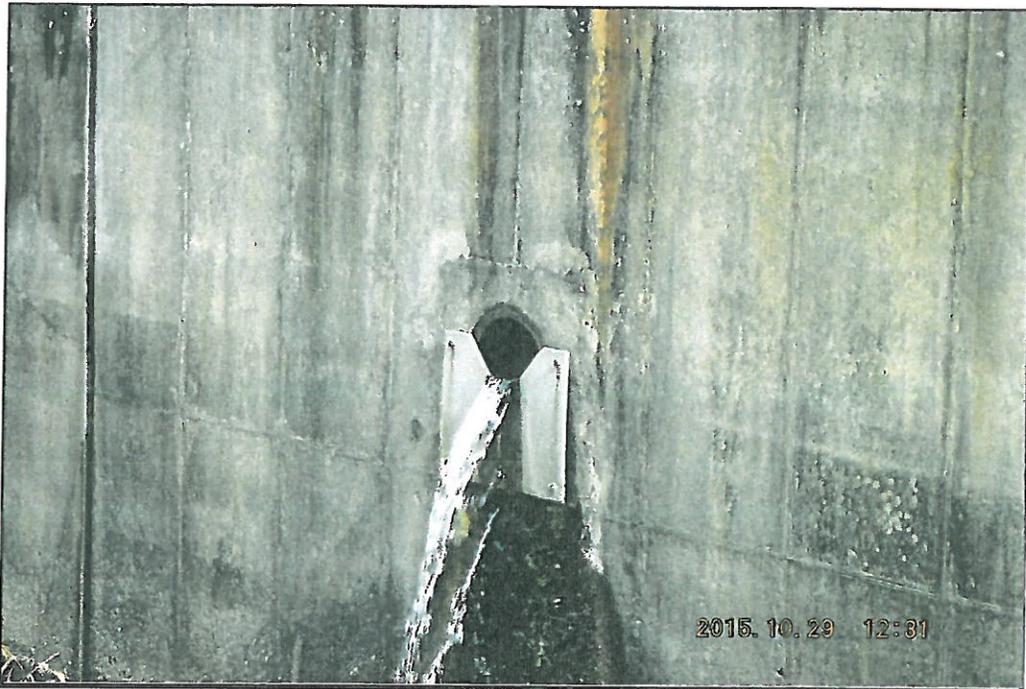
30. outlet headwall. One was flowing at approximately 1 GPM. Some flow was also observed in the drain pipe.

Photo 17: View of Weired Seepage Outlet through Eastern Spillway Wall

6. The seepage weirs at the outlet works headwall should be monitored, as well as the flow (assumed to be leakage) exiting the conduit itself.

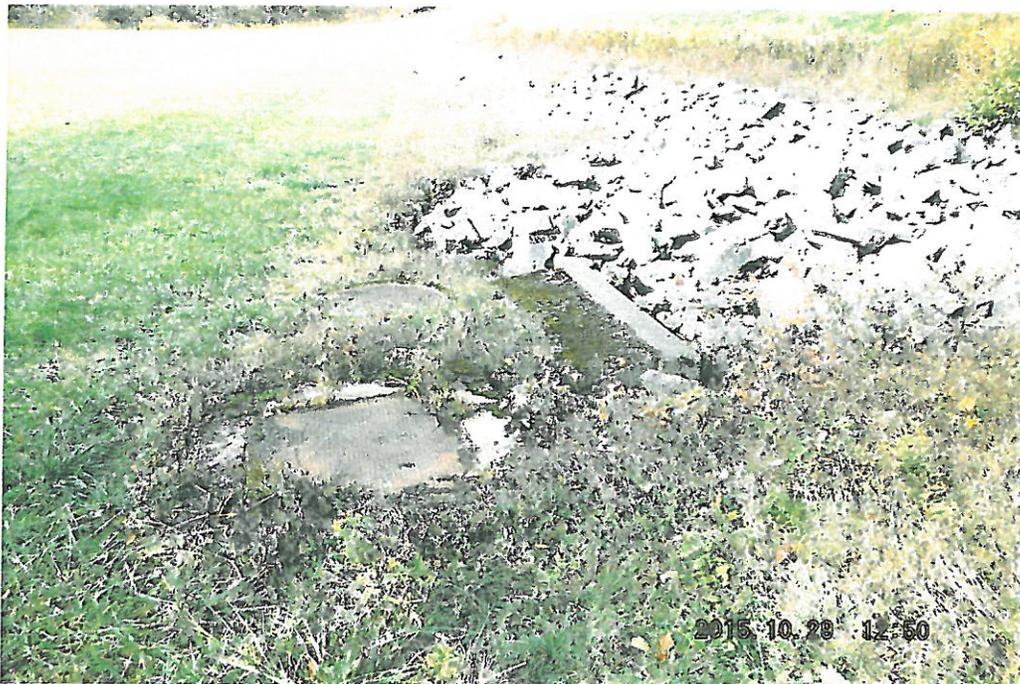
Photo 18: View of Junction Box for Drain Pipe Extension at Toe of Embankment

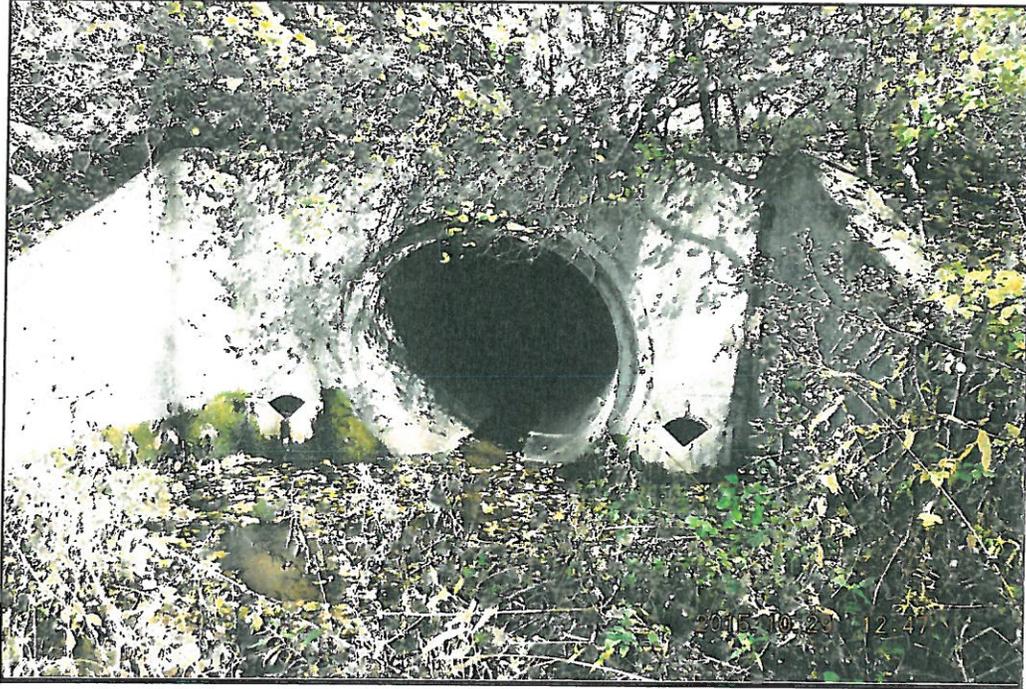
Photo 19: View of Reservoir Drain Outlet
