ANNUAL RESERVOIR INSPECTION

EBENSBURG STORAGE DAM

DEP ID No. D11-061

OCTOBER, 2015

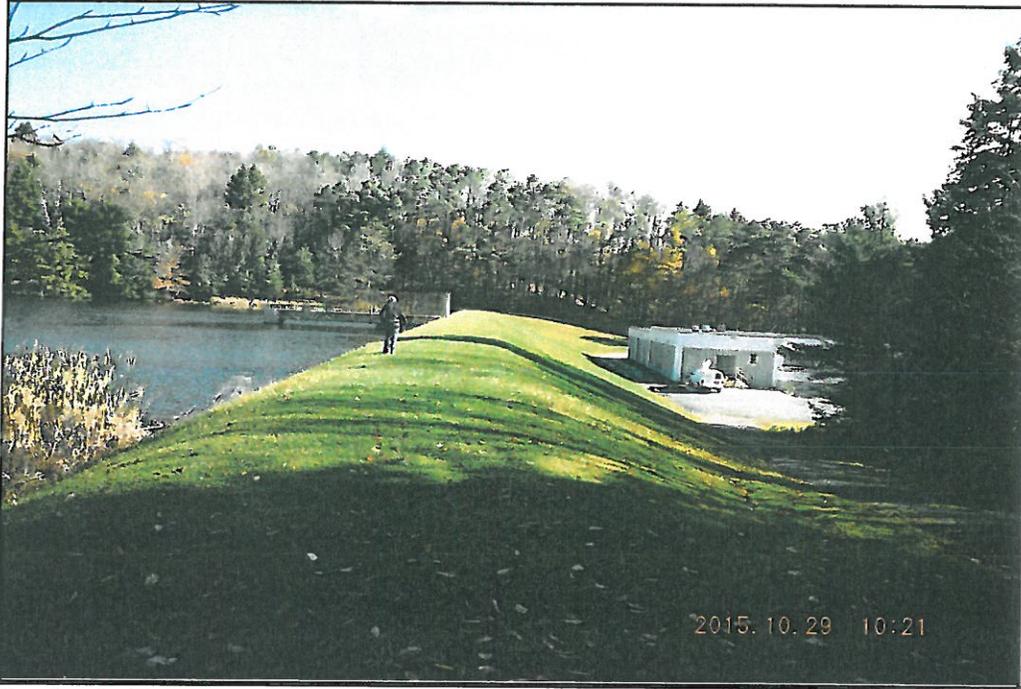
Photo 1: Downstream Embankment and Crest looking Northeast

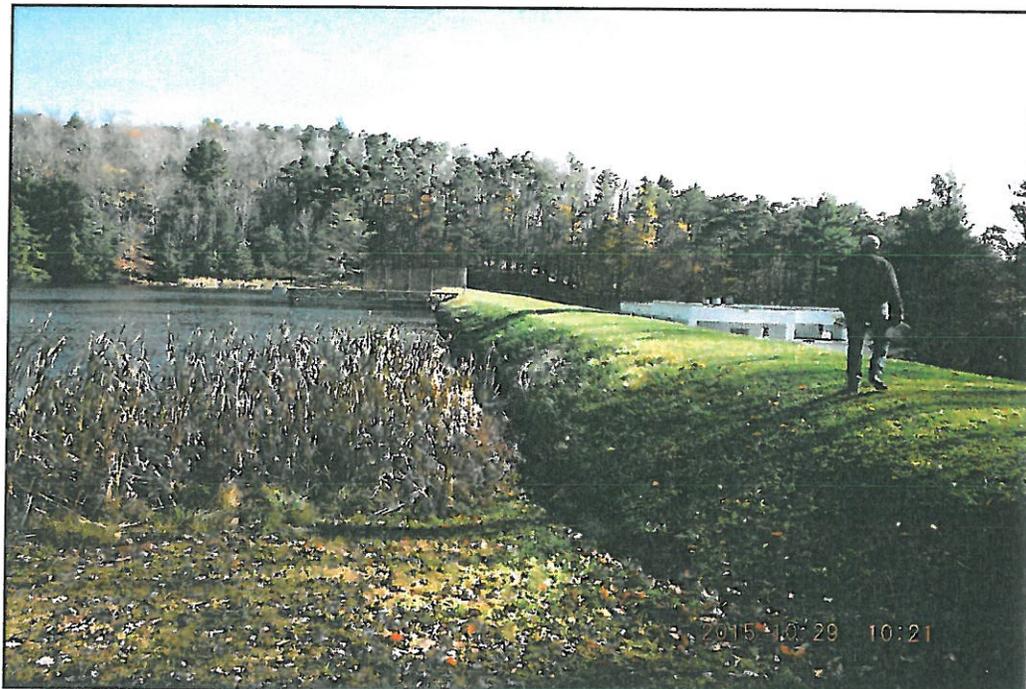
Photo 2: Upstream Embankment looking Northeast

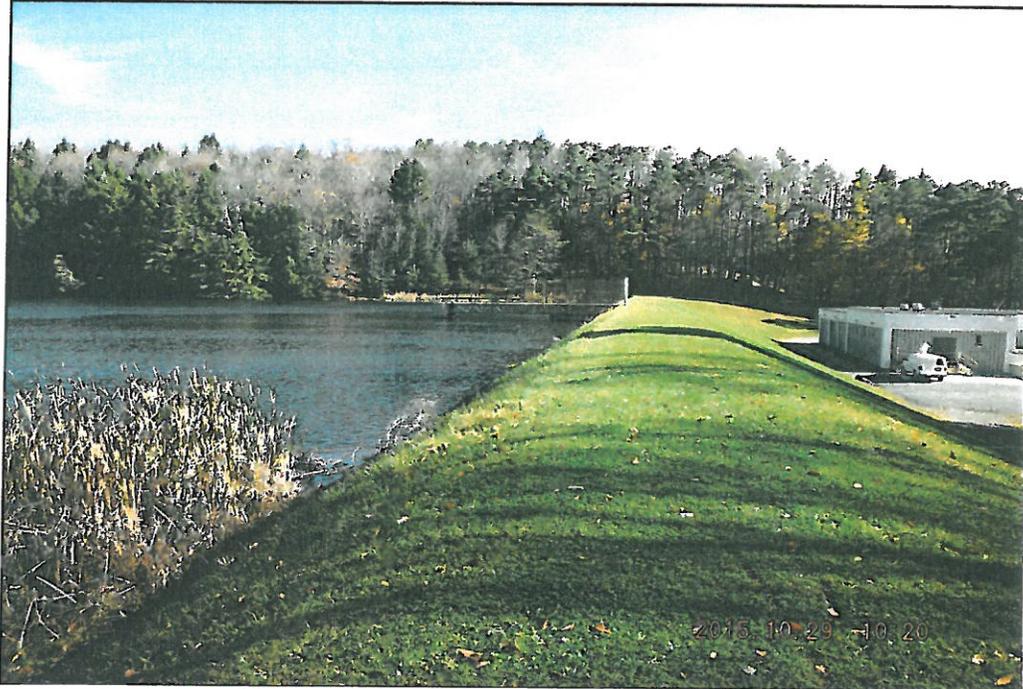
Photo 3: Crest looking Northeast

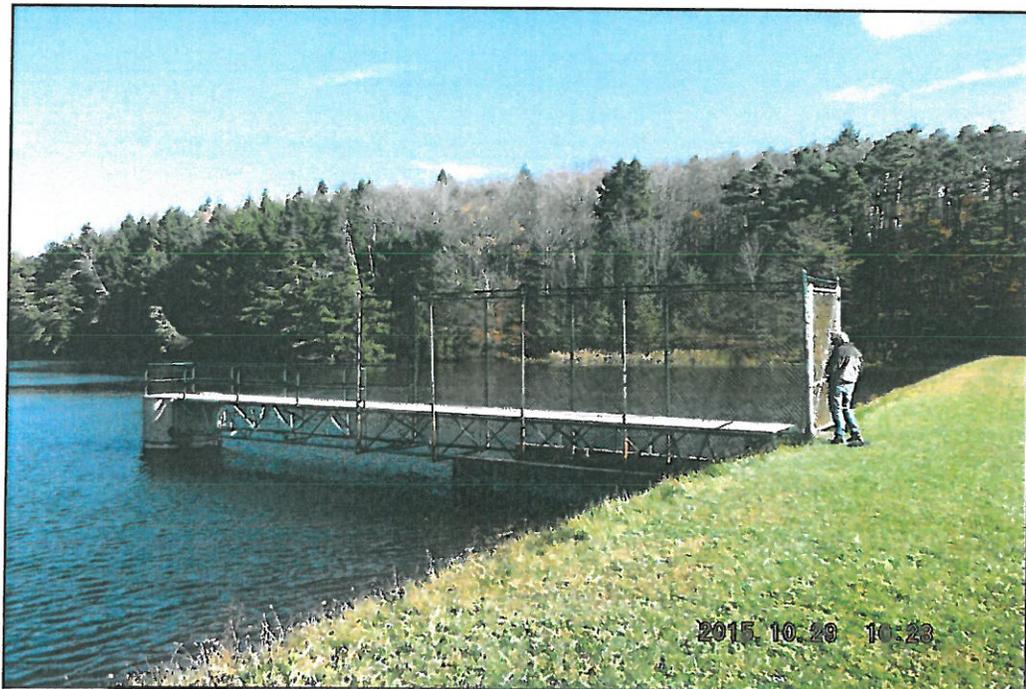
Photo 4: Intake Structure, Bridge and Gated Access

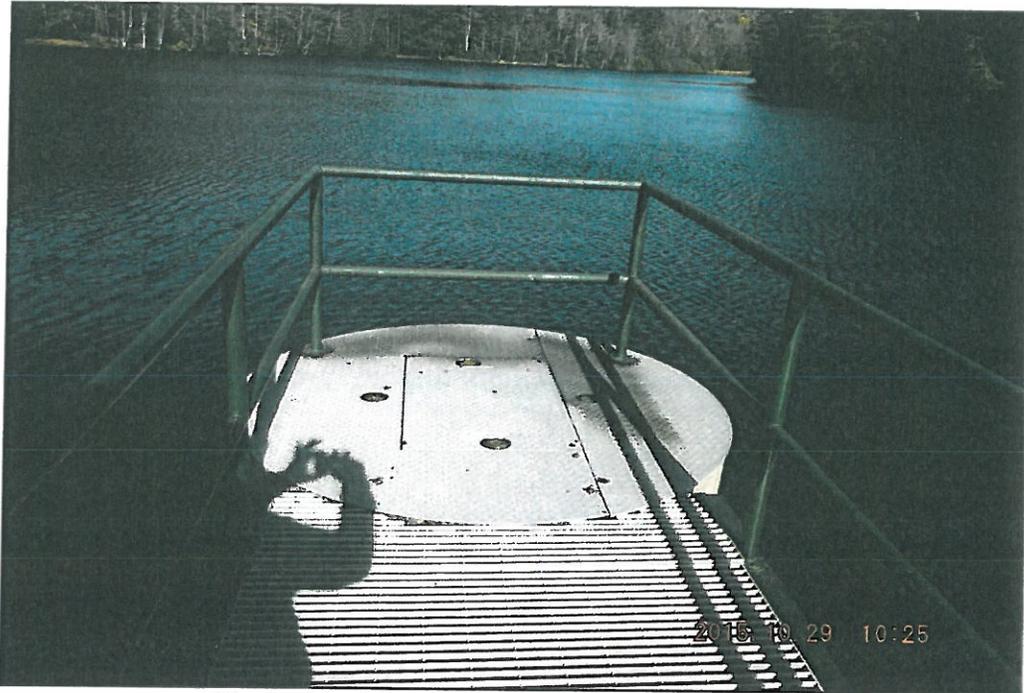
Photo 5: View of Intake Structure Top

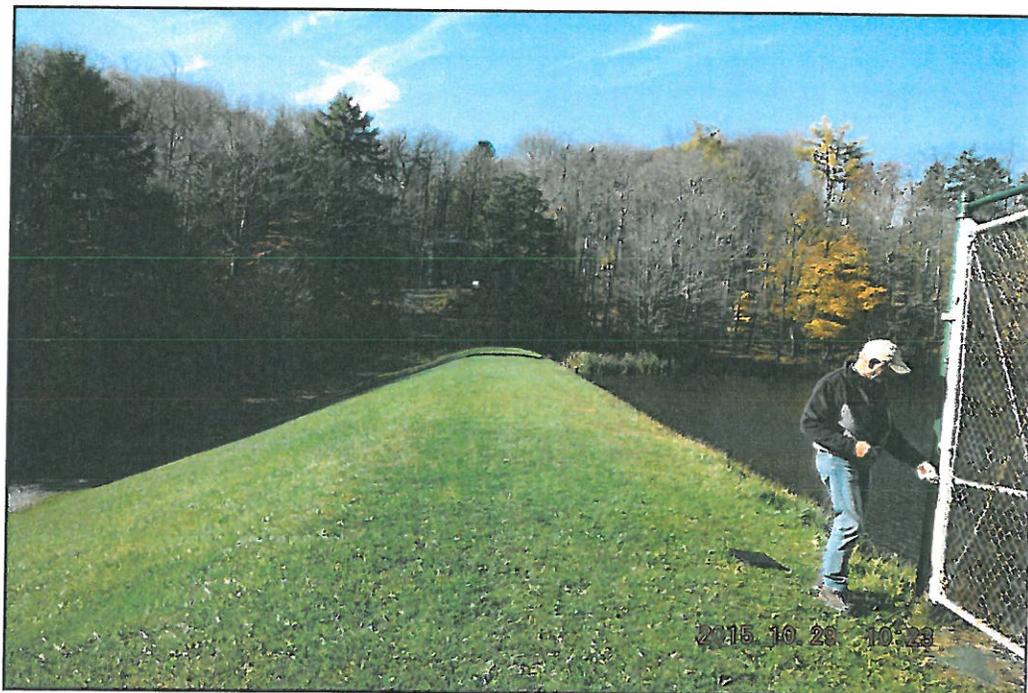
Photo 6: Crest from the Middle looking Southwest

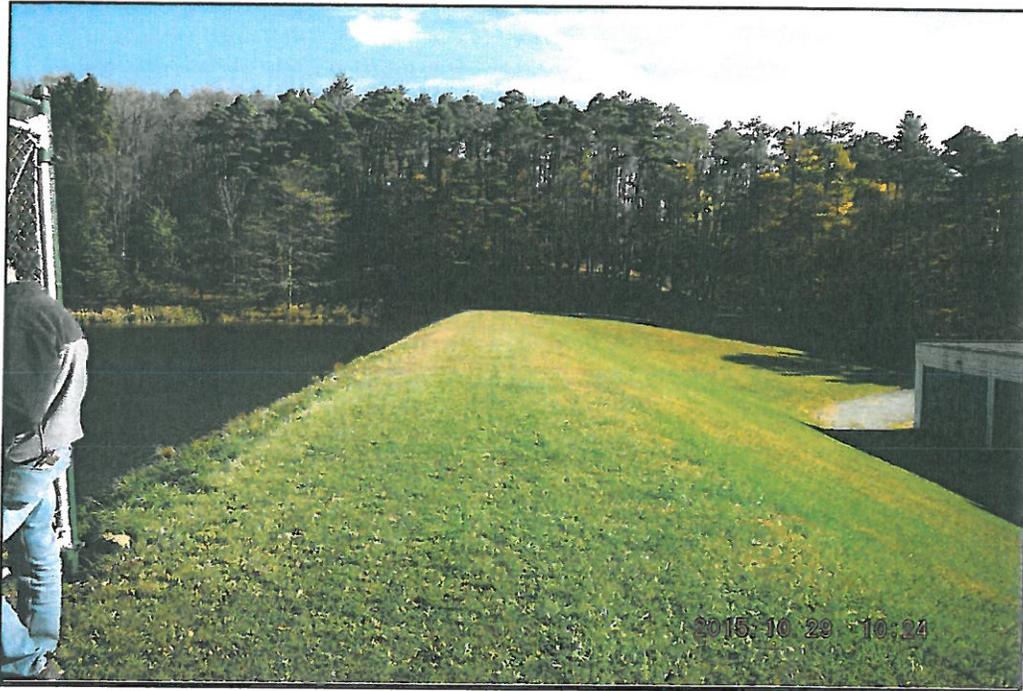
Photo 7: Crest from the Middle looking Northeast

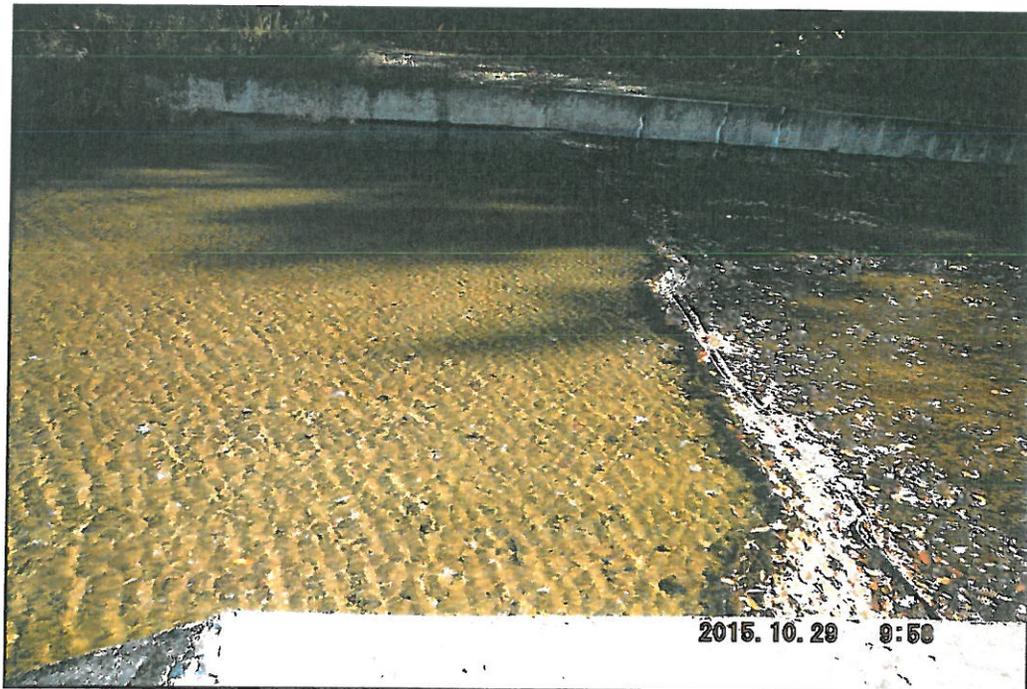
Photo 8: Spillway Control Section looking Northeast

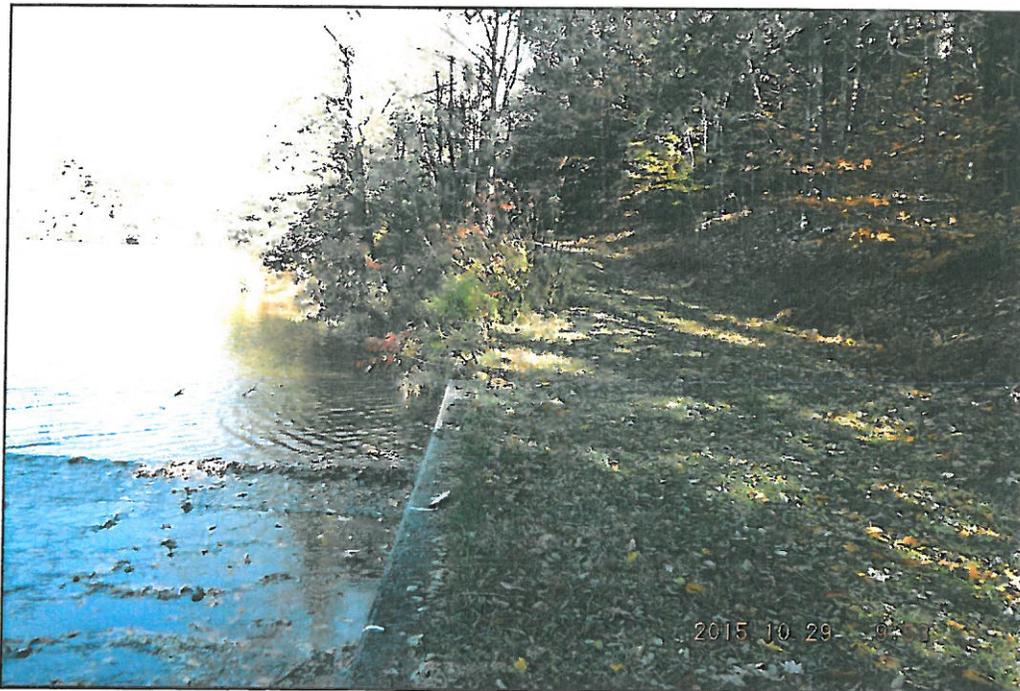
1. Vegetative cover on the dam crest and embankment was well maintained. However, an area along the left abutment should be cleared of woody growth (See Photo 9). This was also addressed in last year's report.
2. The biggest concern with this dam is the outlet works. According to the Public Works director:
 - a. No valve or gate exists within the inlet structure.
 - b. The drain valve located within a manhole near the entrance to the water treatment plant was opened last year, but much difficulty was encountered when attempting to close it. For this reason, the valve was not exercised this year.
 - c. The 20" ± drain pipe outlets into Howell's Run, but is submerged.
 - d. The pipe network is made up of several different materials.

Photo 9: Woody Vegetation at Left Abutment

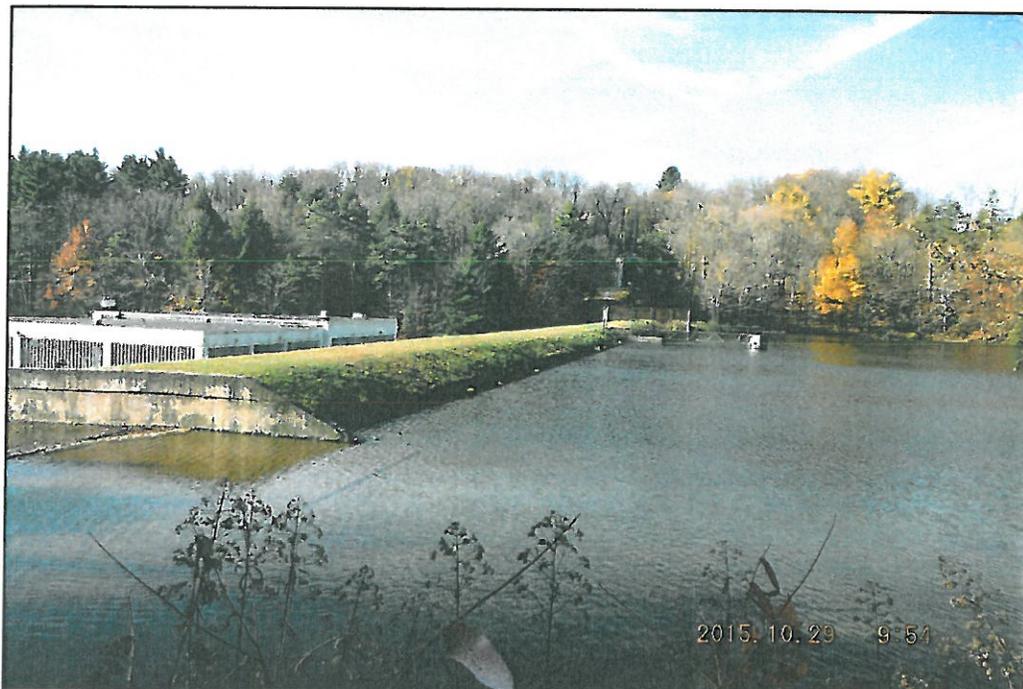
Photo 10: Spillway Entrance and Upstream Embankment looking Southwest

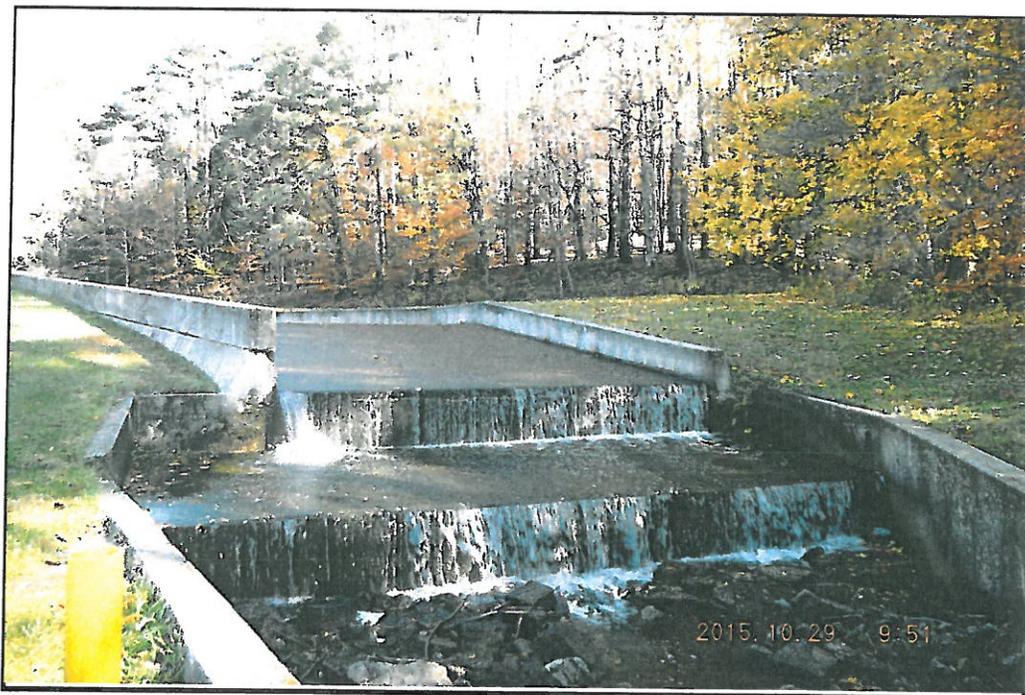
Photo 11: Downstream Section of Spillway

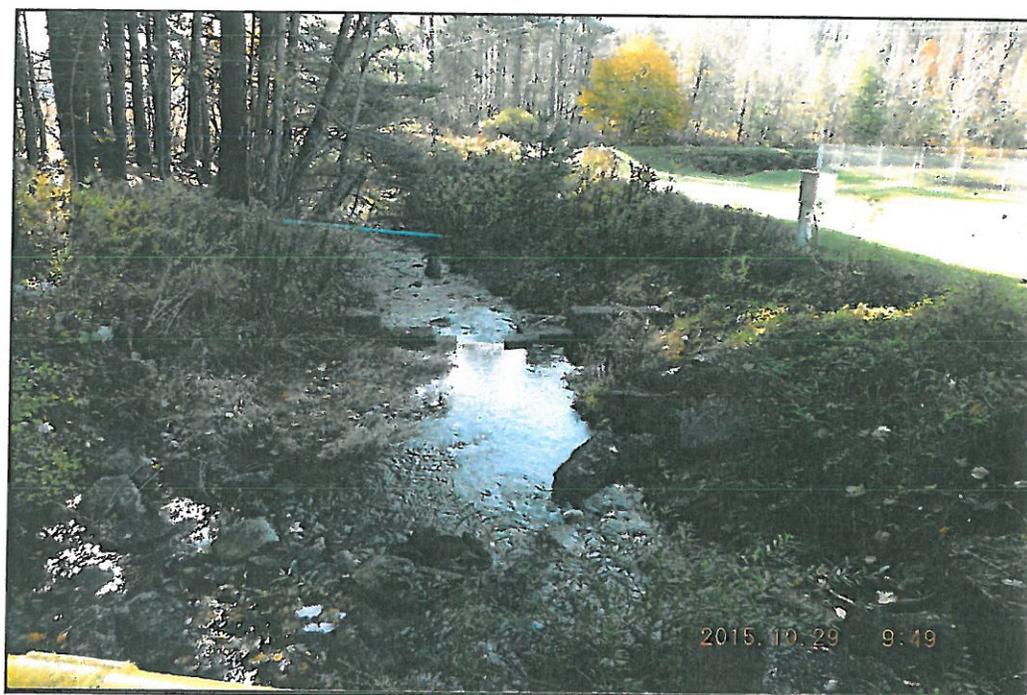
Photo 12: View of Weir on Discharge Channel Used for Measuring Conservation Release

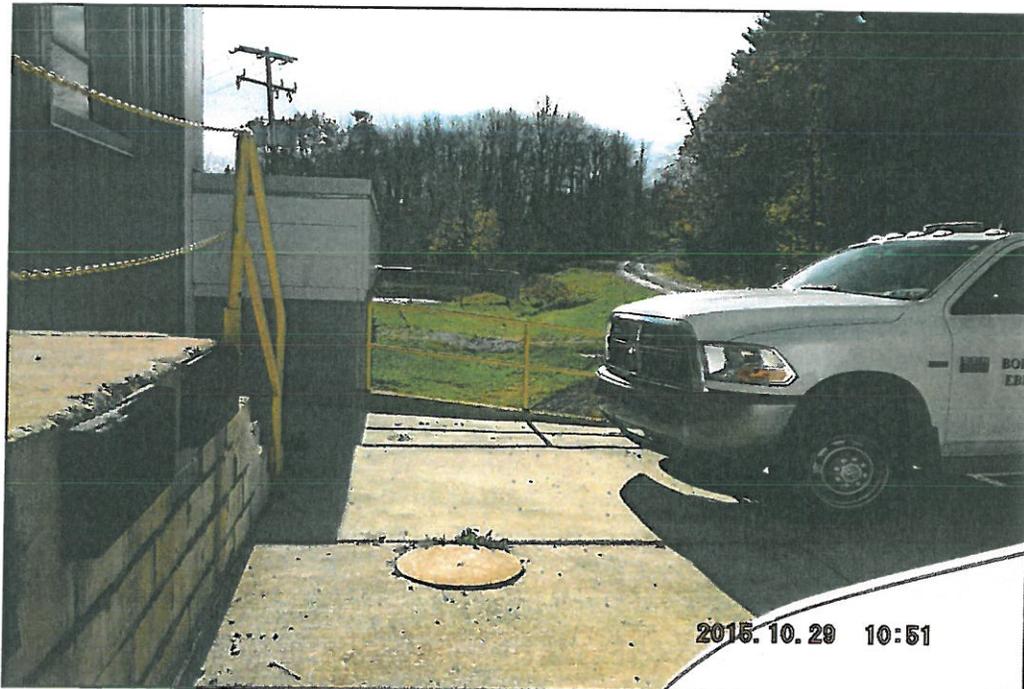
74. entrance to the water treatment plant. (See Photo 14). According to the dam owner, the valve was operated a year or so ago, but issues were encountered during efforts to close and seal the valve. The entire closure and drain pipe system is in need of an upgrade. The drain outlet is submerged within the channel of Howells Run downstream of the water treatment plant.

Photo 14: View of Reservoir Drain Valve Manhole

It is obvious that the outlet work is in need of attention. Since the pipe outlet is submerged and no other access to the network is available, the dam will need to be drained just to televise and inspect the conduit. The Borough is currently looking at options to improve operations at the water treatment plant which is located adjacent and just downstream of the Dam. Because of this, we suggest that work related to improvements to the dam's outlet works be combined with the potential improvements of the treatment plant. This would include the drawdown of the dam. During the next several months, we will work with Borough officials to develop a plan that addresses both issues.
