RE: 2020 Inspection of Ebensburg Storage Dam
DEP File No. 011-061
Project No. 15-0017.102

ANNUAL RESERVOIR INSPECTION

EBENSBURG STORAGE DAM

DEP ID No. D11-061

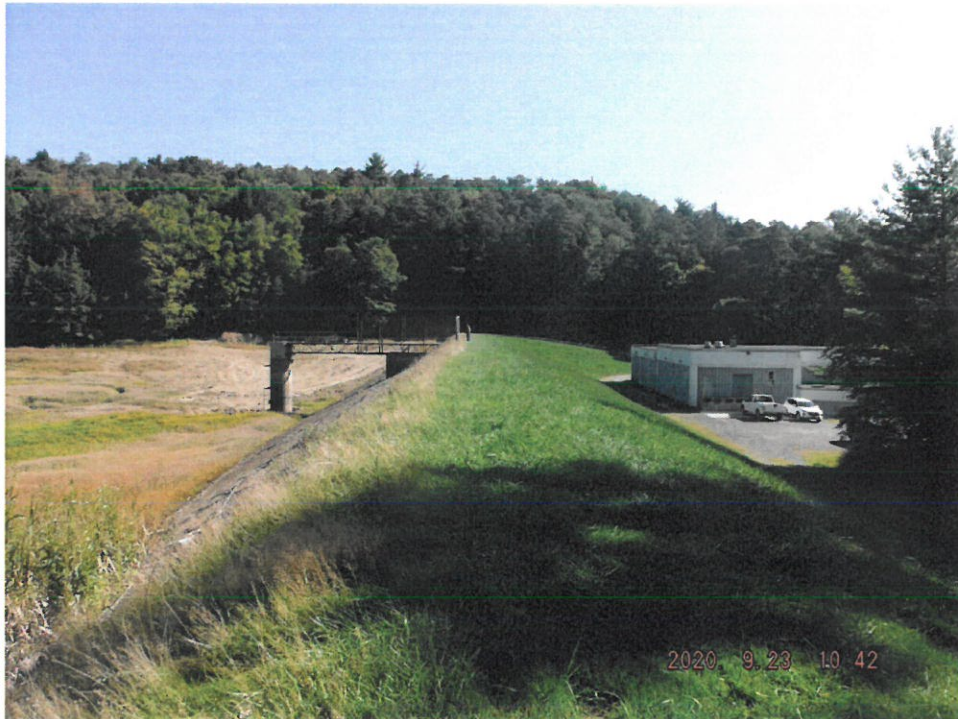
Photo 1: Downstream Embankment and Crest looking Northeast

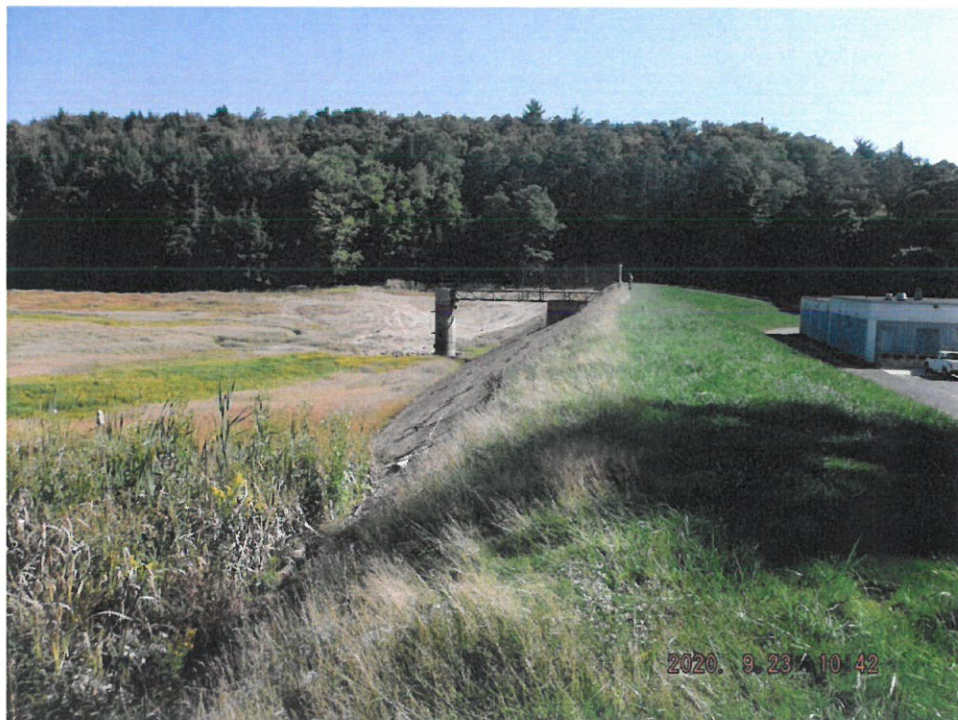
Photo 2: Upstream Embankment looking Northeast

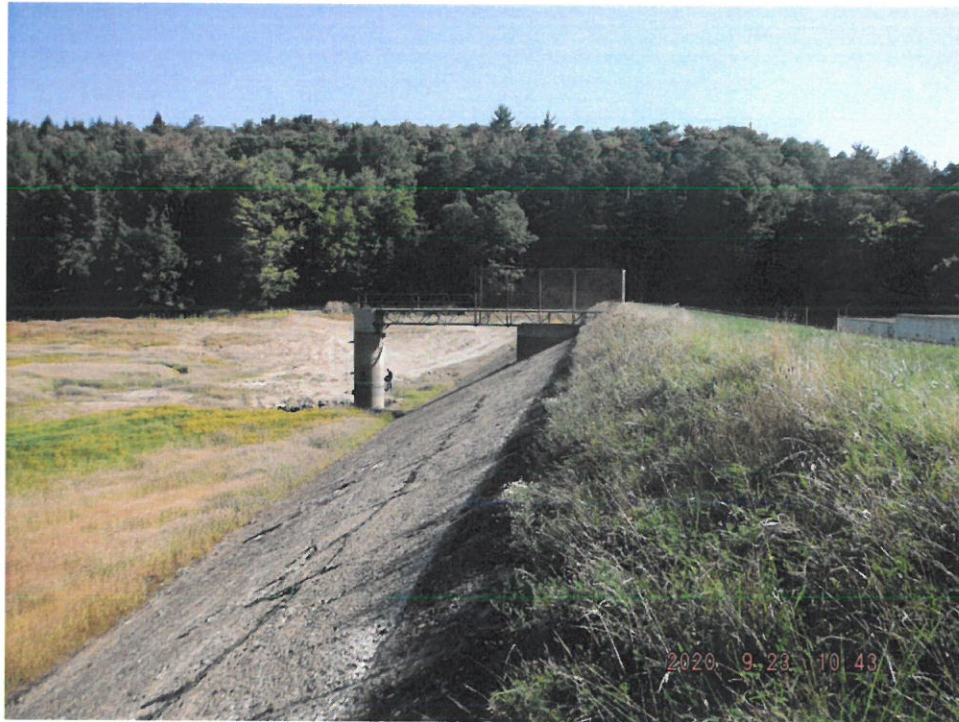
Photo 3: Upstream Embankment looking Northeast

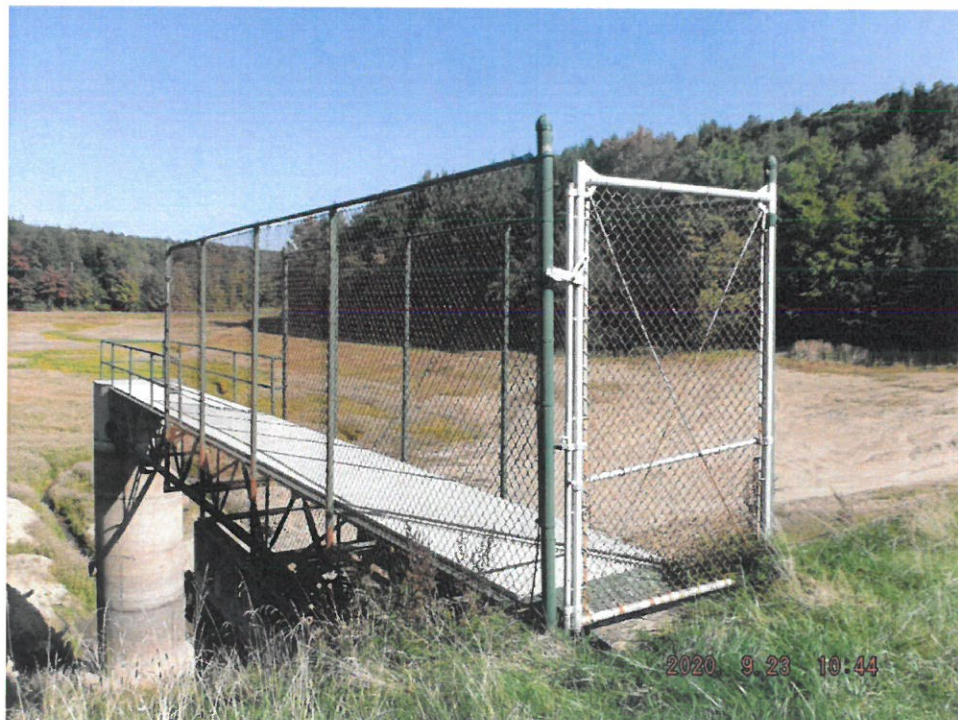
Photo 4: Intake Structure, Bridge and Gated Access

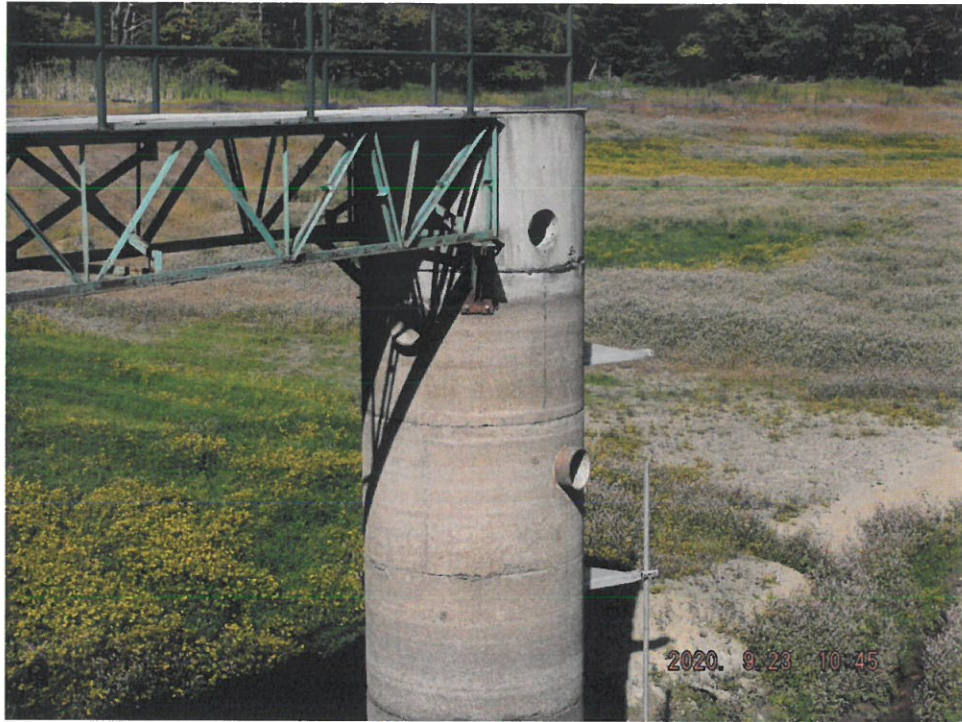
Photo 5: View of Intake Structure

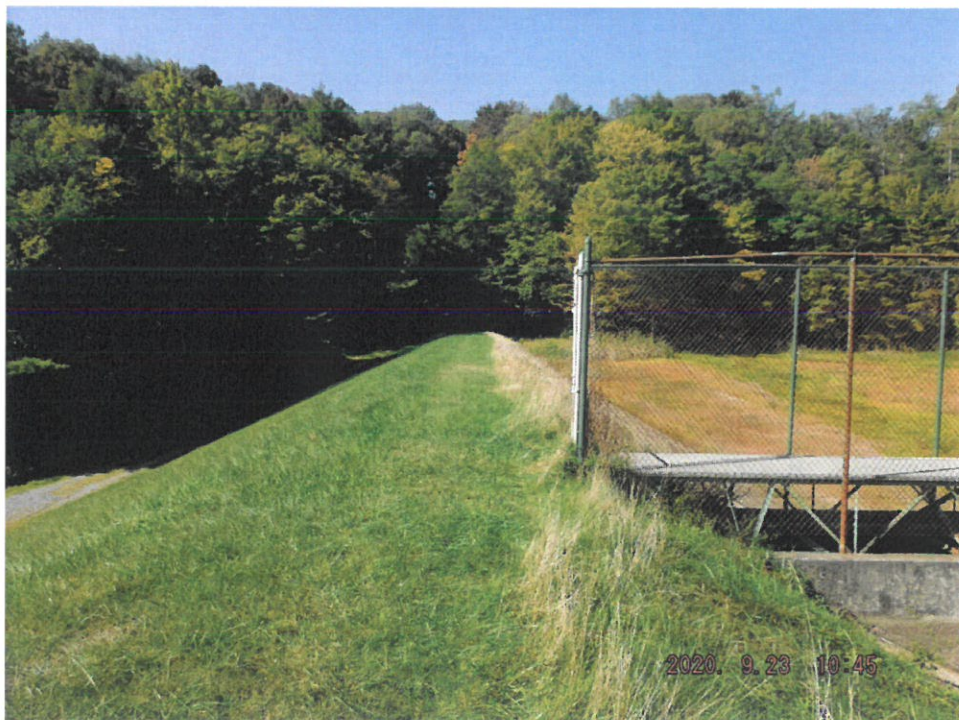
Photo 6: Crest from the Middle looking Southwest

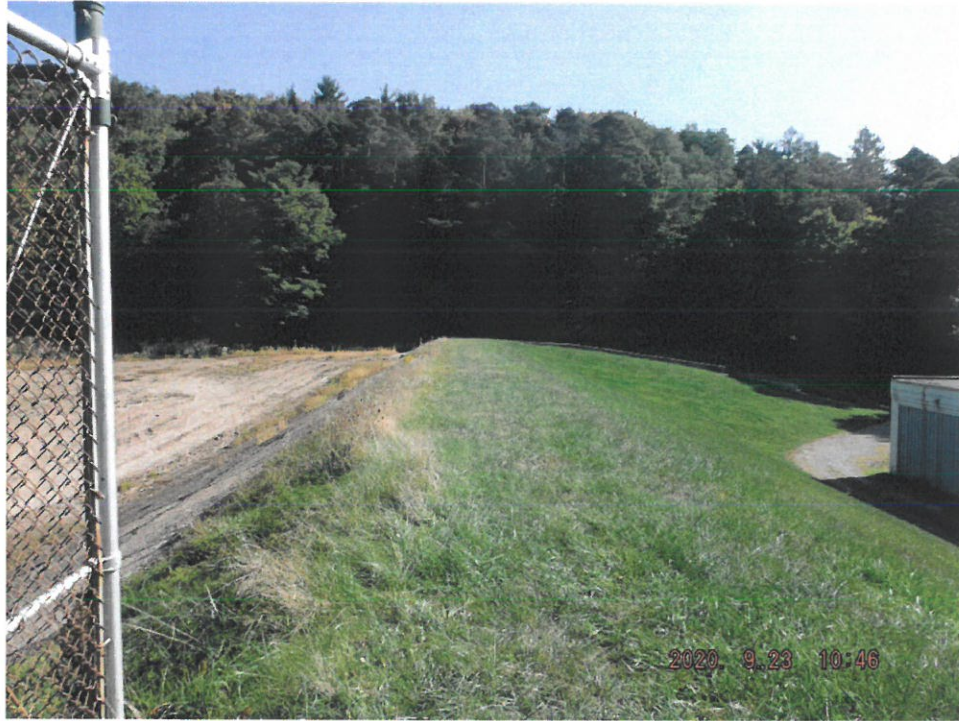
Photo 7: Crest from the Middle looking Northeast

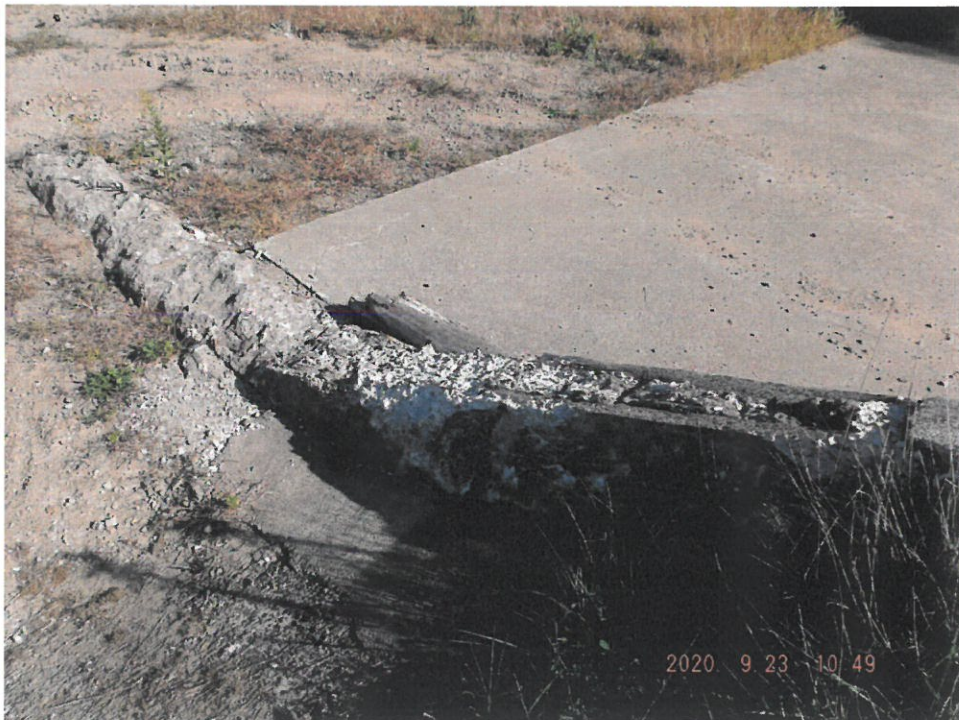
Photo 8: Spillway Control Section looking Northeast

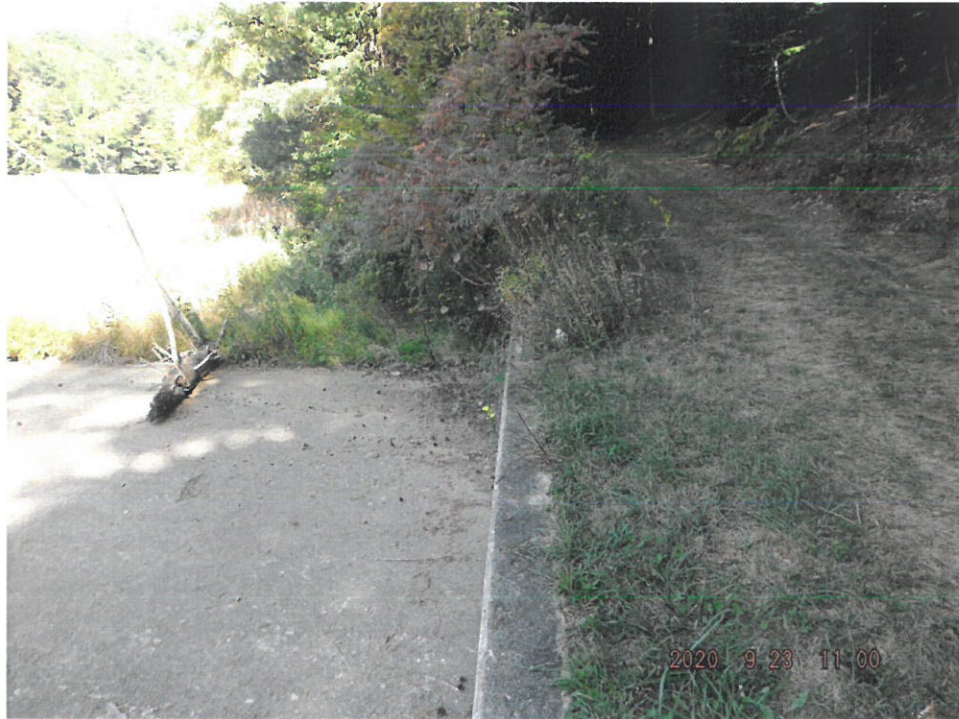
Photo 9: Woody Vegetation at East Abutment

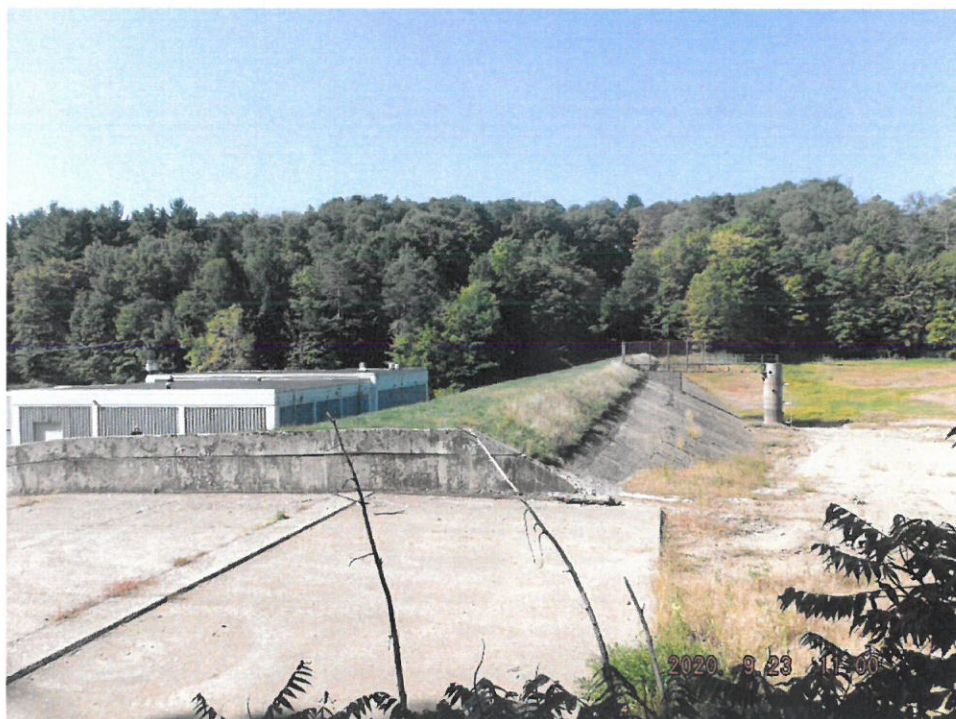
Photo 10: Spillway Entrance and Upstream Embankment
looking Southwest

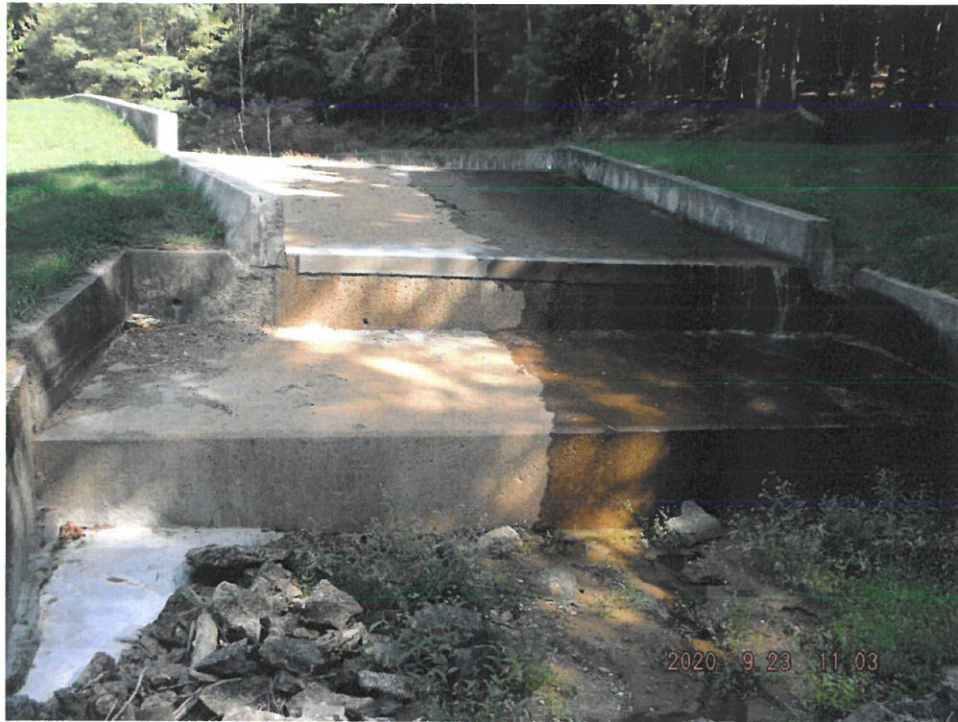
Photo 11: Downstream Section of Spillway

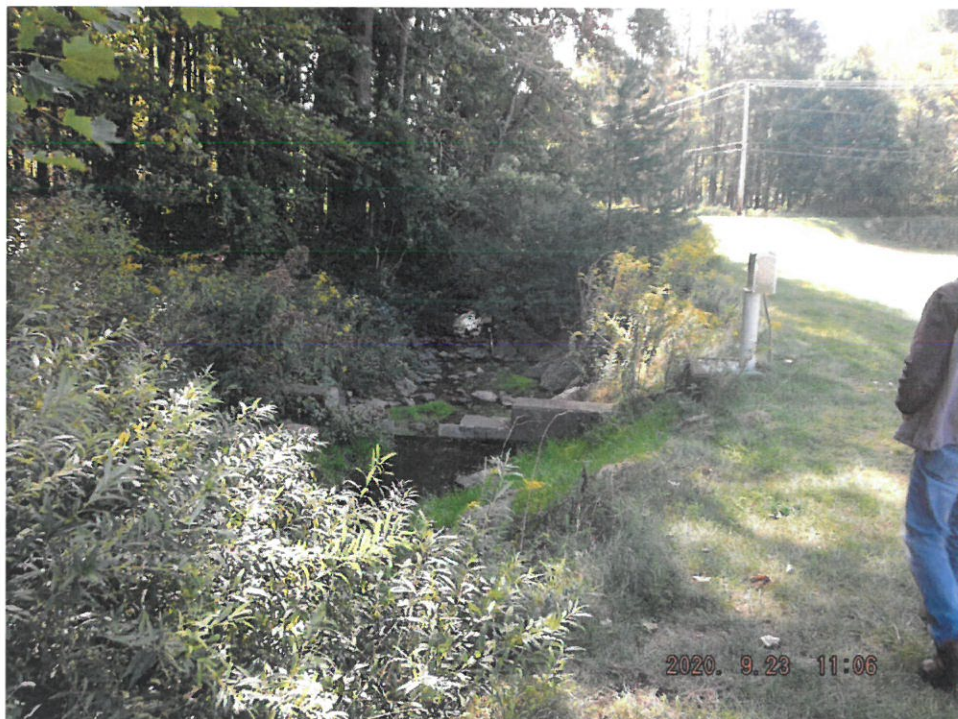
Photo 12: View of Weir on Discharge Channel Used for Measuring Conservation Release

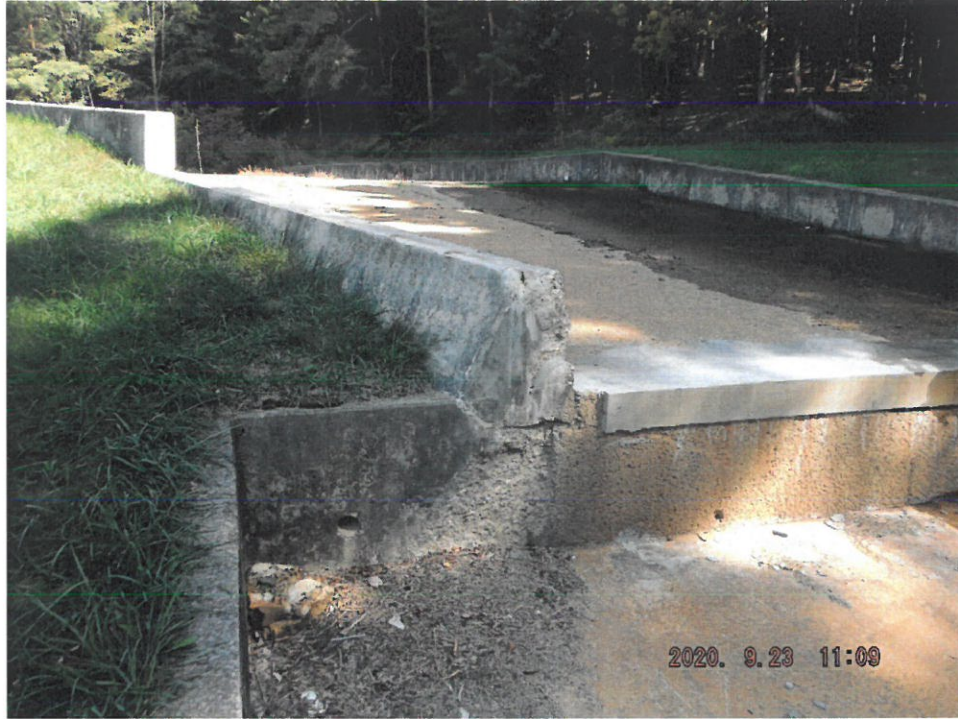
1. Past annual inspection reports had indicated a growing crack present along an upper wall section of the downstream western spillway wall. This wall section had been slowly sliding downhill away from the spillway. In 2019, EMA operational staff removed this section of wall, cutting the remaining concrete flush at the location of the crack. See Photos 13 and 18.

Photo 13: Recently Removed Upper Section of the Western Spillway Wall
(EMA operational staff removed portion of wall in 2019)

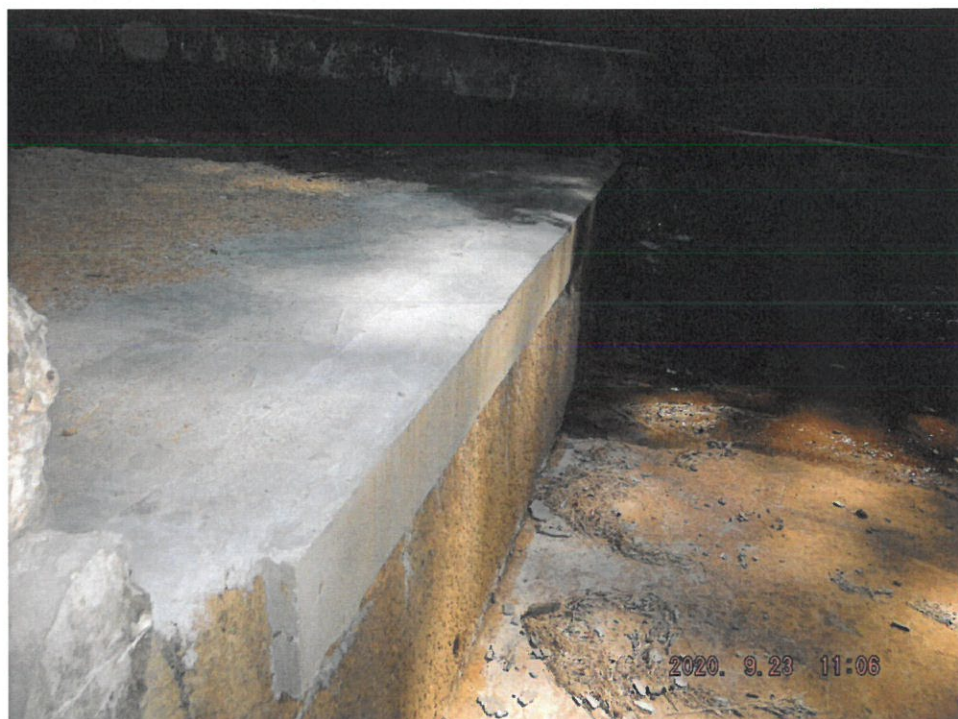
Photo 14: Portion of downstream spillway channel
patched/repared by EMA operational staff in 2019

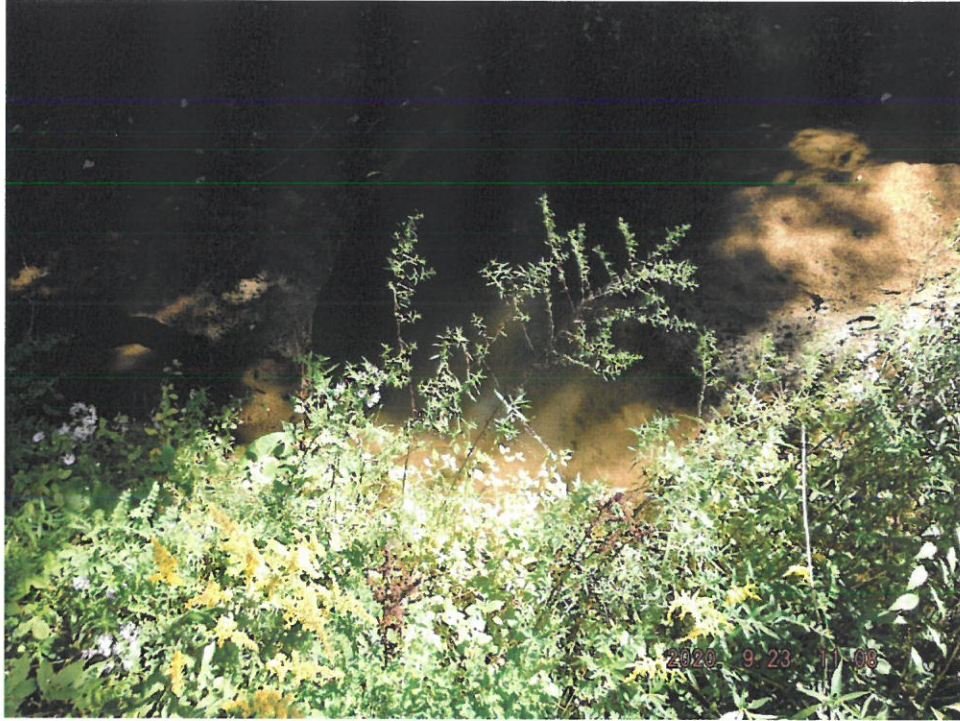
Photo 15: View of Submerged Reservoir Drain Outlet

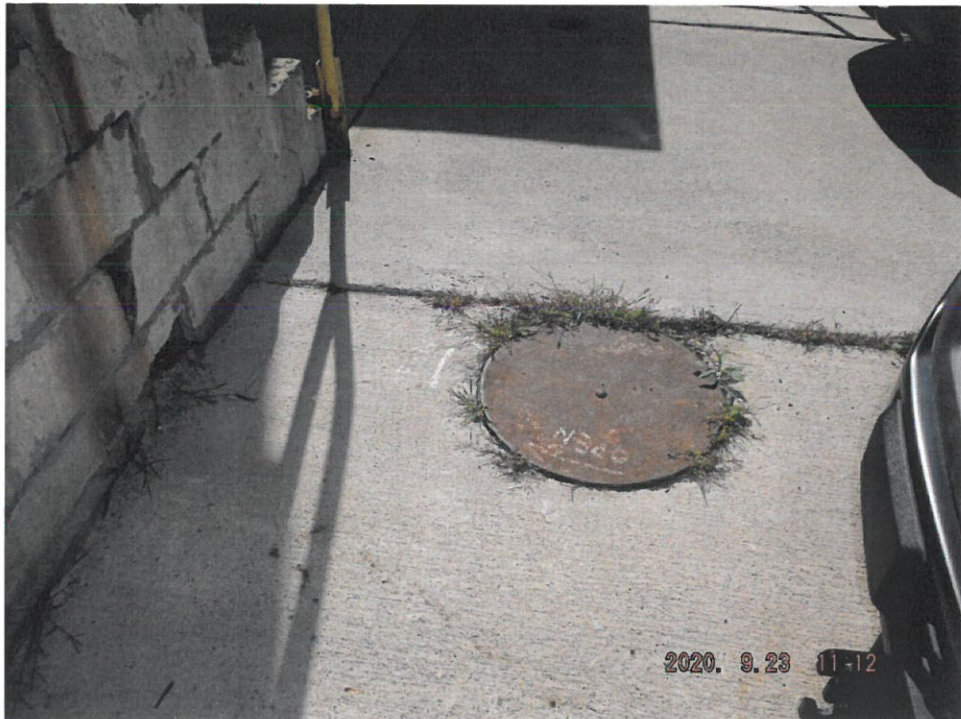
74. entrance to the water treatment plant. (See Photo 16). This valve was exercised in September 2019 to initiate the drawdown process.

Photo 16: View of Reservoir Drain Manhole

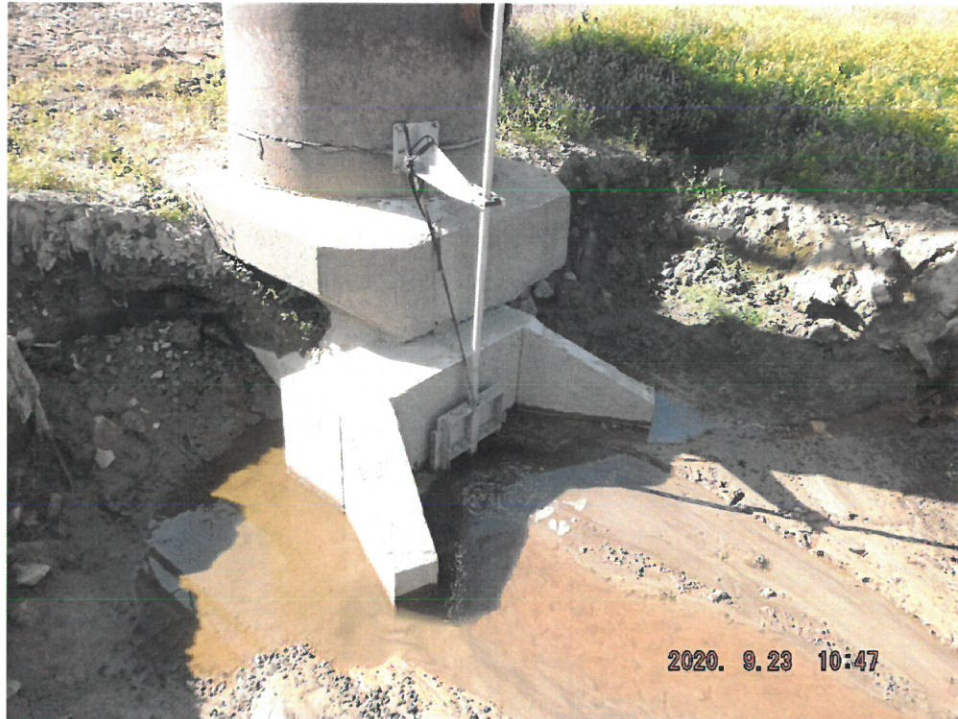
73. Permit application for the installation of a sluice gate was submitted in September 2016 and a "Letter of Amendment" was issued by the PA DEP on Dec. 15, 2016. The 20" S.S. Sluice Gate has been installed (See Photo 17), however the valve's operator and stem have not been installed at the time of the inspection. EMA expects their installation to occur in the coming months, allowing the reservoir to begin filling immediately thereafter.

Photo 17: Newly installed primary closure drain valve.
(20" Stainless Steel Sluice Gate)

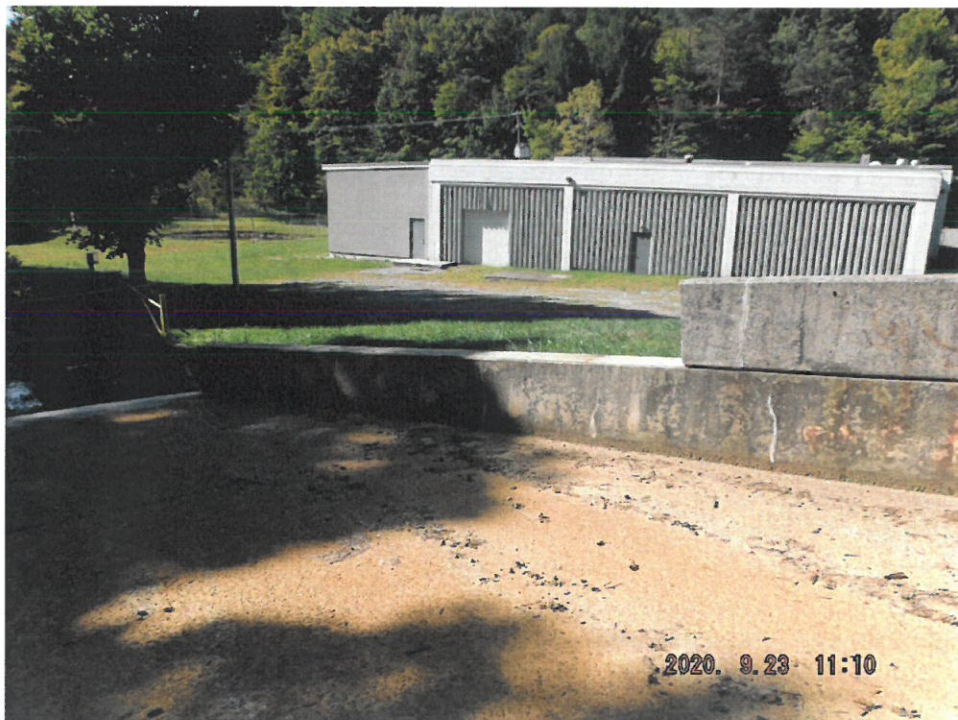
Photo 18: Recently Removed Upper Section of the Western Spillway Wall
(EMA operational staff removed portion of wall in 2019)
