Relevant Observation:

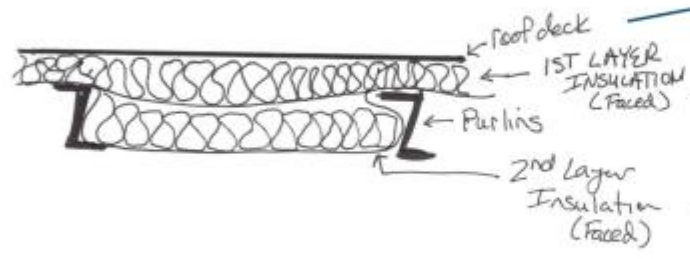
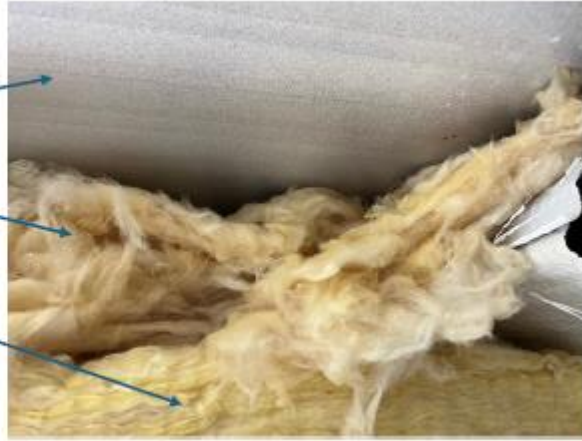
Insulation method of building is a 2-layer system (Pictures and drawing attached). The top layer is a faced fiberglass insulation that rests on top of purlins, between the purlins and roof deck. Estimated to be 4" (R-10) Lower layer is faced fiberglass insulation that rests in the purlin cavity utilizing the long tab method. This faced system has the tabs attached to the top-level insulation. Estimated to be 6" (R-19).

Insulation facing was severely compromised with ball holes over entire space.

The insulation facing was dried out and delaminating. This was most likely a result of the old HID lighting system and the high level of UV light that this lighting system produces. Current vapor barrier properties appear to no longer exist as a result of this condition.

- 1) Install SporTuff liner attached to bottom face of the purlins.
- 2) Install insulation back in the area where it was removed.

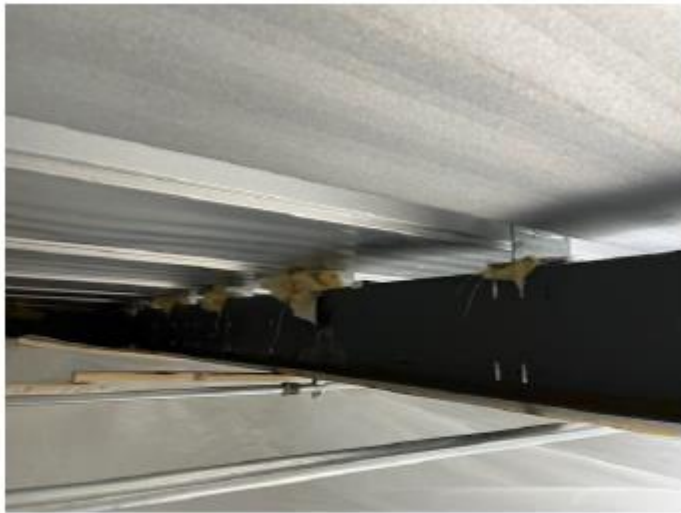
In small section of court one, both levels of insulation were removed.

← Area where insulation was removed
