RE: 2023 Inspection of Ebensburg Storage Dam
DEP File No. 011-061
Project No. 15-0017.102

ANNUAL RESERVOIR INSPECTION

EBENSBURG STORAGE DAM

DEP ID No. D11-061

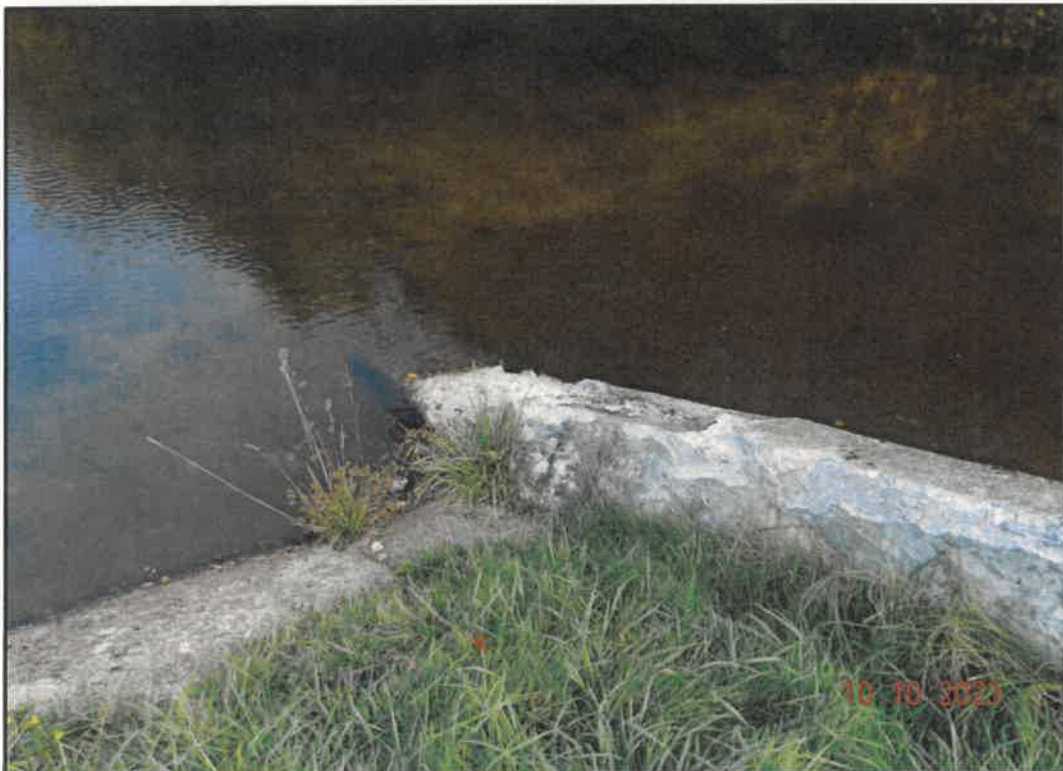
56. The sidewalls exhibit sporadic hairline cracks with efflorescence throughout. There is advanced spalling on the top of the west sidewall at the upstream end of the spillway (Photo 8). The portion of the west side upper wall section which had experienced a major crack and been separating from the upstream spillway wall was removed by EMA operational staff in 2019. See Photos 13 and 17.

Photo 8: Spillway Control Section looking Northeast

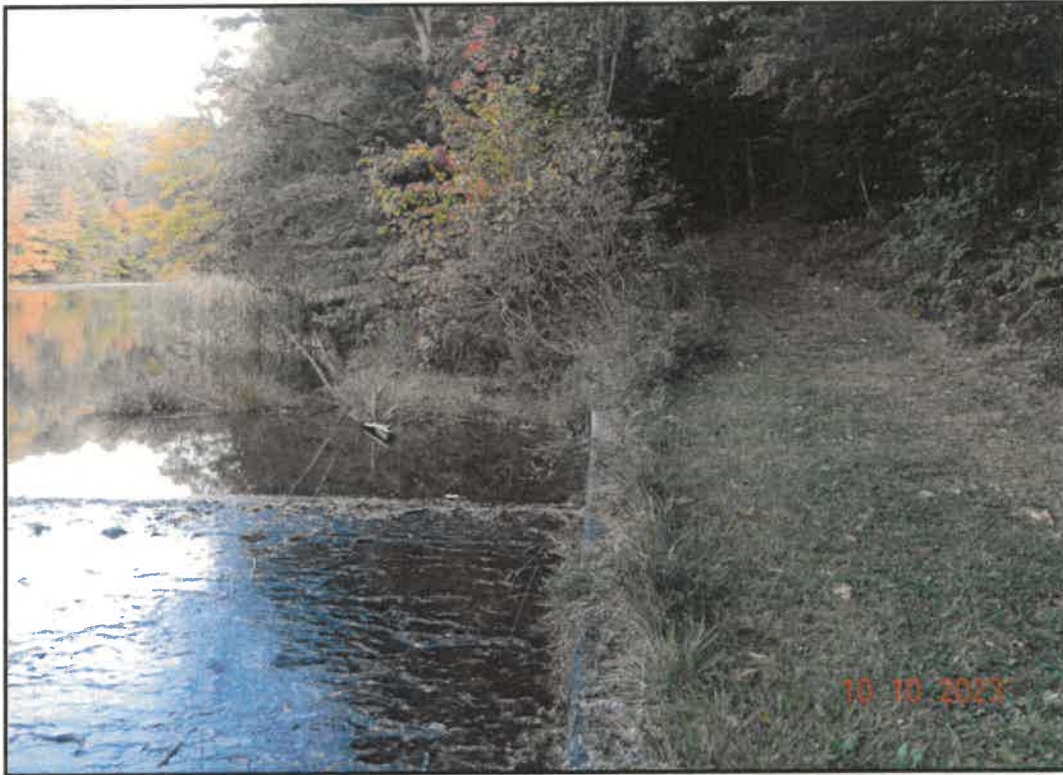
Photo 9: Woody Vegetation at East Abutment

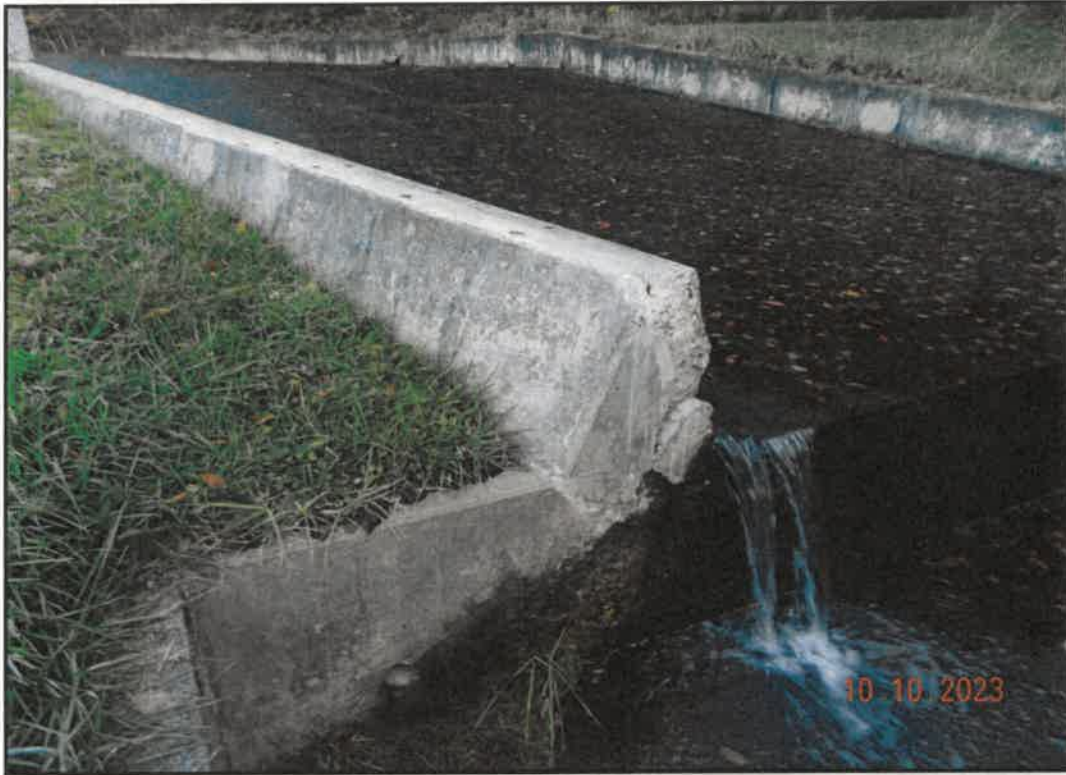
1. Past annual inspection reports had indicated a growing crack present along an upper wall section of the downstream western spillway wall. This wall section had been slowly sliding downhill away from the spillway. In 2019, EMA operational staff removed this section of wall, cutting the remaining concrete flush at the location of the crack. See Photos 13 and 18.

Photo 13: Recently Removed Upper Section of the Western Spillway Wall (EMA operational staff removed portion of wall in 2019)

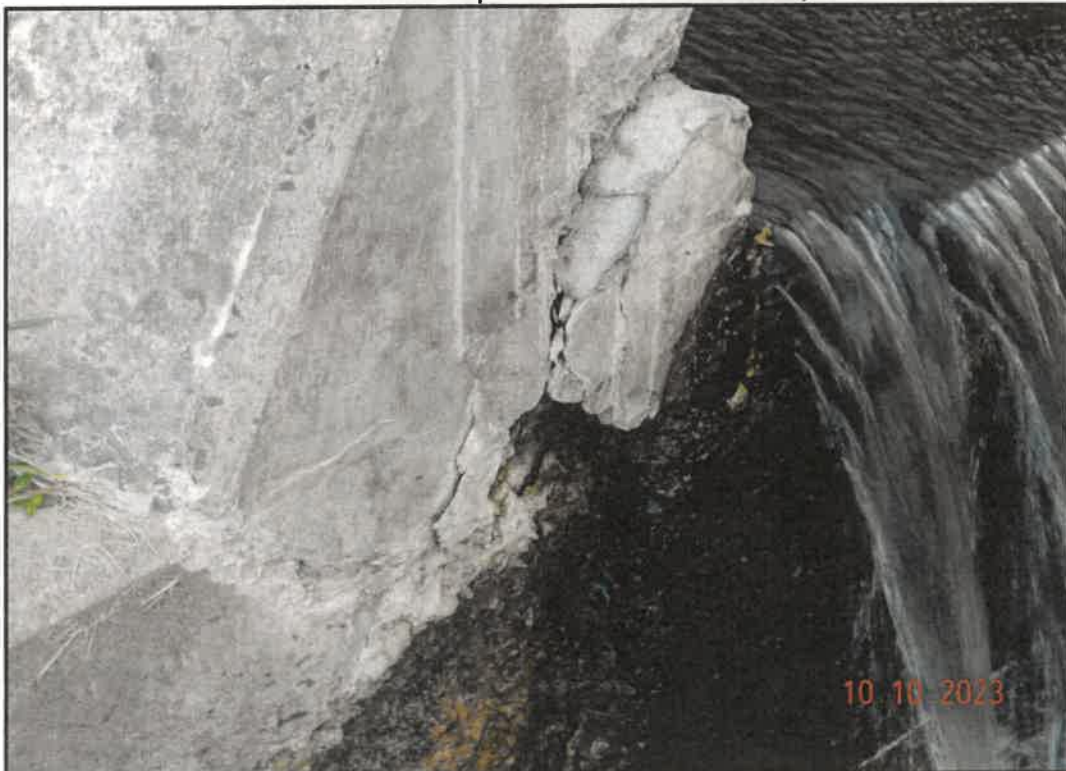
57. In 2019 concrete patching / repairs were performed at the lip of the downstream spillway, near the portion of the removed upper wall section. See Photo 14

Photo 14: Portion of downstream spillway channel patched/repared by EMA operational staff in 2019

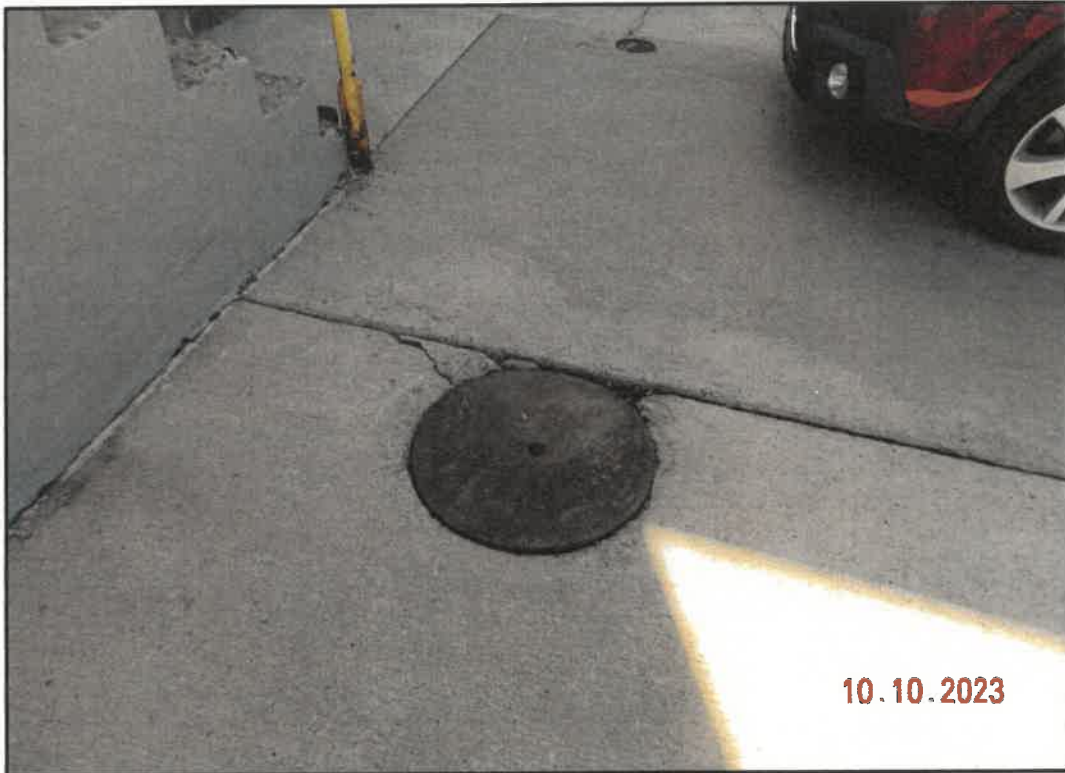
74. entrance to the water treatment plant. (See Photo 15). This valve was last exercised in September 2019

Photo 15: View of Reservoir Drain Manhole

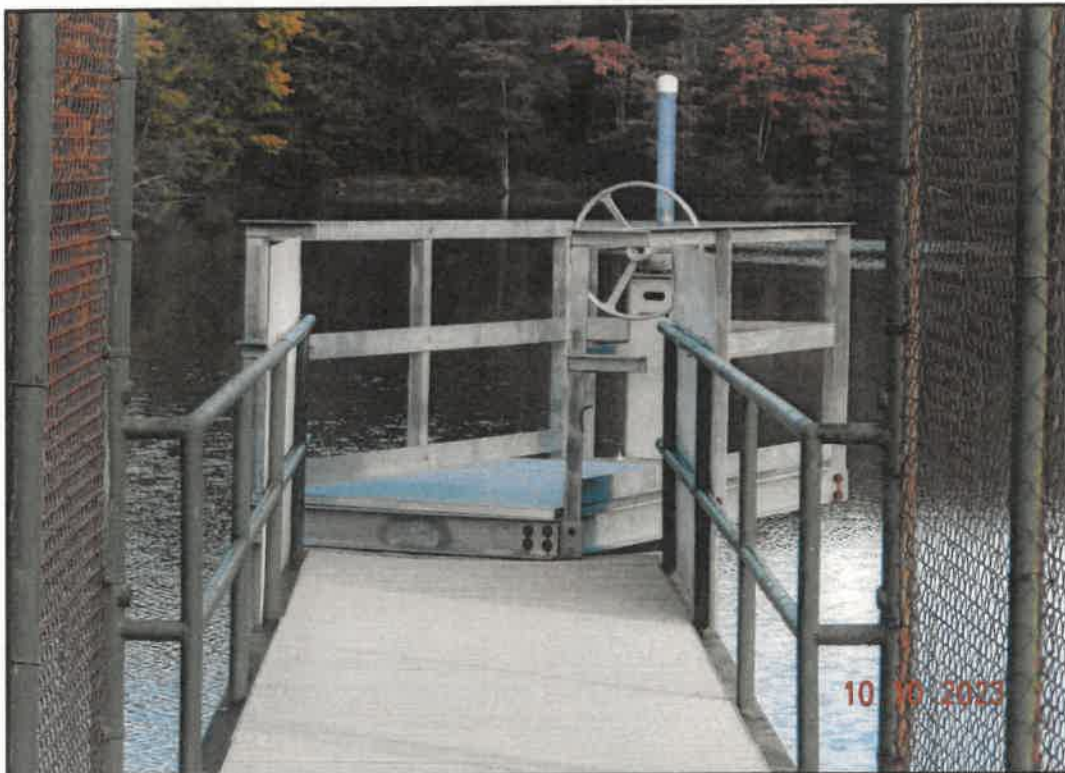
73. A new primary closure, 20" S.S. sluice gate was installed in early-2021. An access platform was also constructed atop the intake tower.

Photo 16: Newly installed primary closure drain valve operator and access platform. (20" Stainless Steel Sluice Gate)

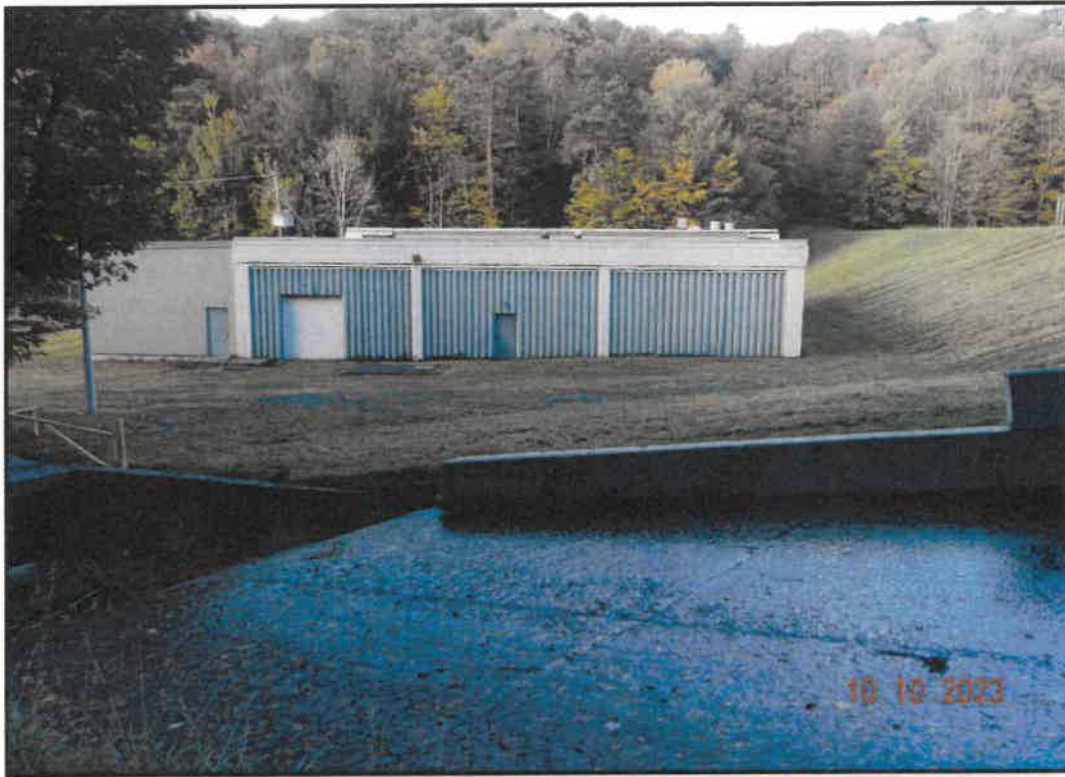
Photo 17: Recently Removed Upper Section of the Western Spillway Wall (EMA operational staff removed portion of wall in 2019)

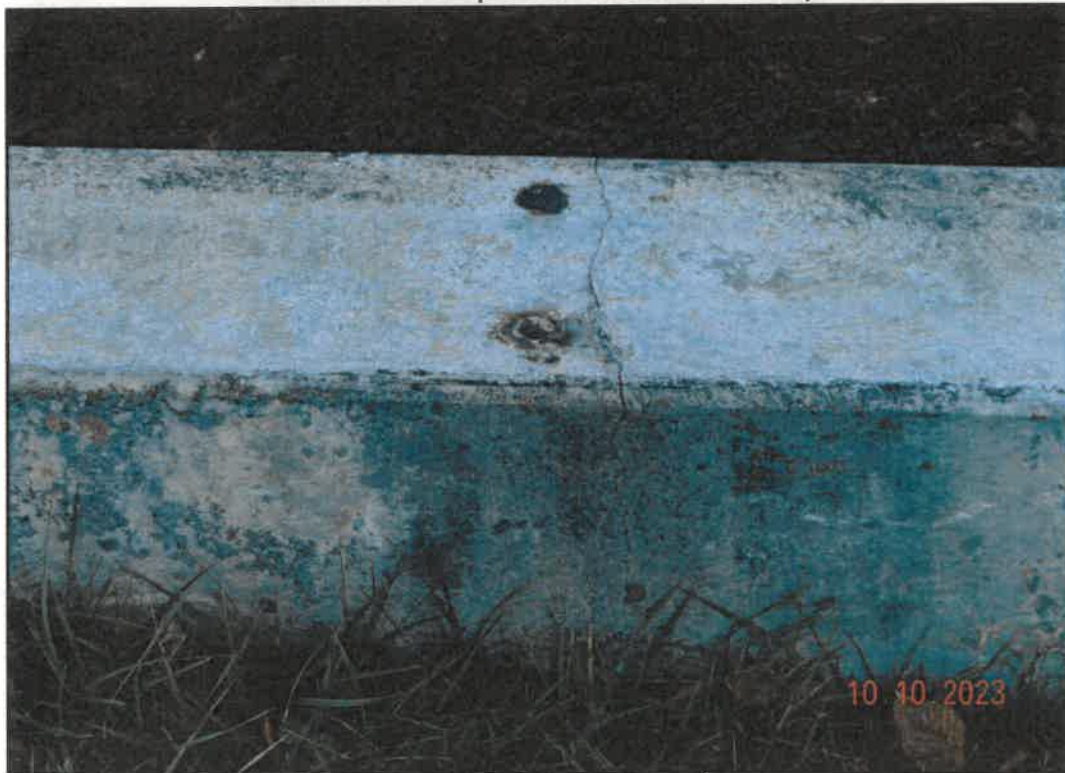
- a. Three (3) hairline cracks were noted on the lower wall section (see Photo 18) at the location where the upper wall section had previously been removed. The cracks should be monitored moving forward to ensure the lower wall section does not slide in the same way that the upper section did.

In 2022, a small hairline crack was noted on the lower wall section (see Photo 18) at the location where the upper wall section had been removed. Two additional hairline cracks were noted during this year's inspection at this location. The cracks should be monitored moving forward to ensure the lower wall section does not slide similarly to the upper wall section.

Photo 18: Hairline Cracking in Western Spillway Wall

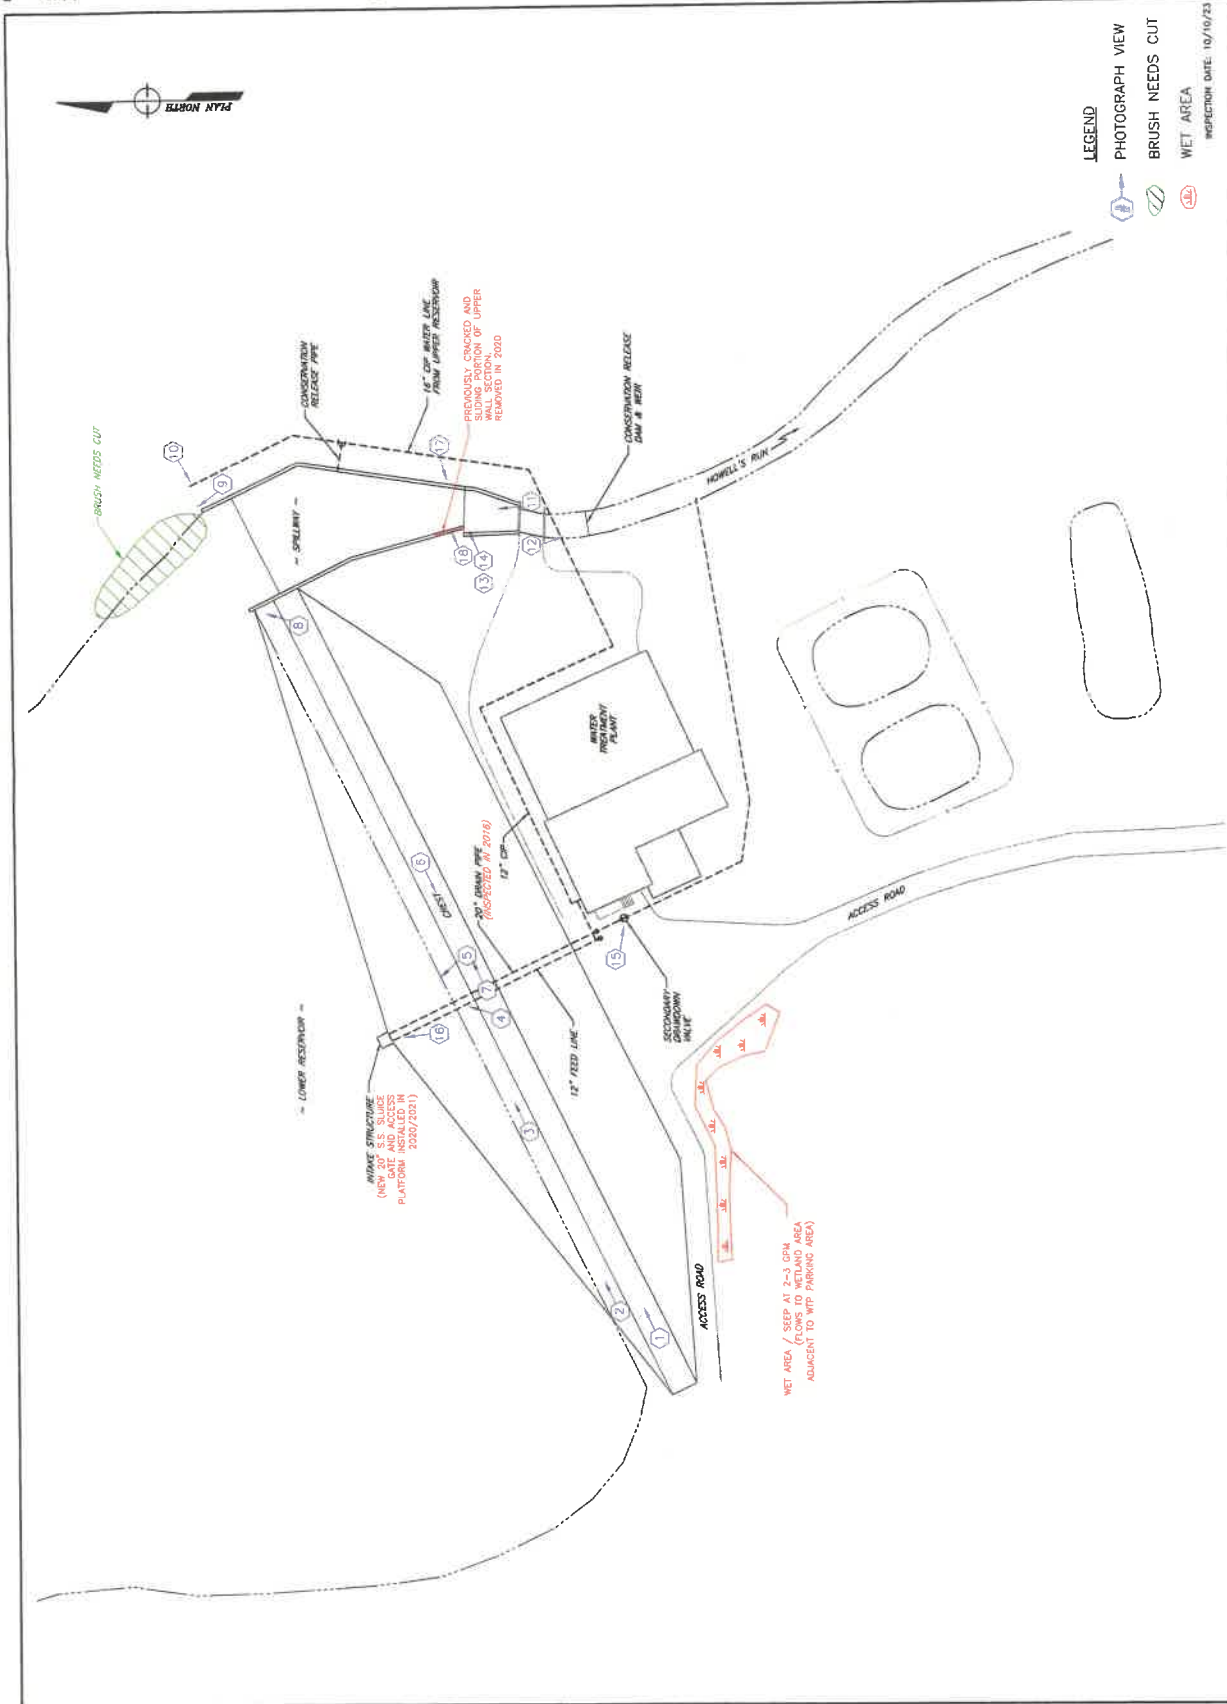
S1

39. A wet area was identified on the southern side of the dam access road (see sketch plan). The flow through this wet area was approx. 2-3 GPM, an increase from last year (approx.. 1 GPM). The wet area extended to a patch of wetlands adjacent to the Water Treatment Plant Parking Area. It is difficult to determine whether this wet area is a result of dam seepage or runoff from the mountainside to the west of the dam. Regardless, this seep should continue to be monitored for any changes moving forward.
