RE: 2023 Inspection of Howell's Run Dam
DEP File No. 11-103
Project No. 15-0017.102

ANNUAL RESERVOIR INSPECTION

HOWELL'S RUN DAM

DEP ID No. D11-103

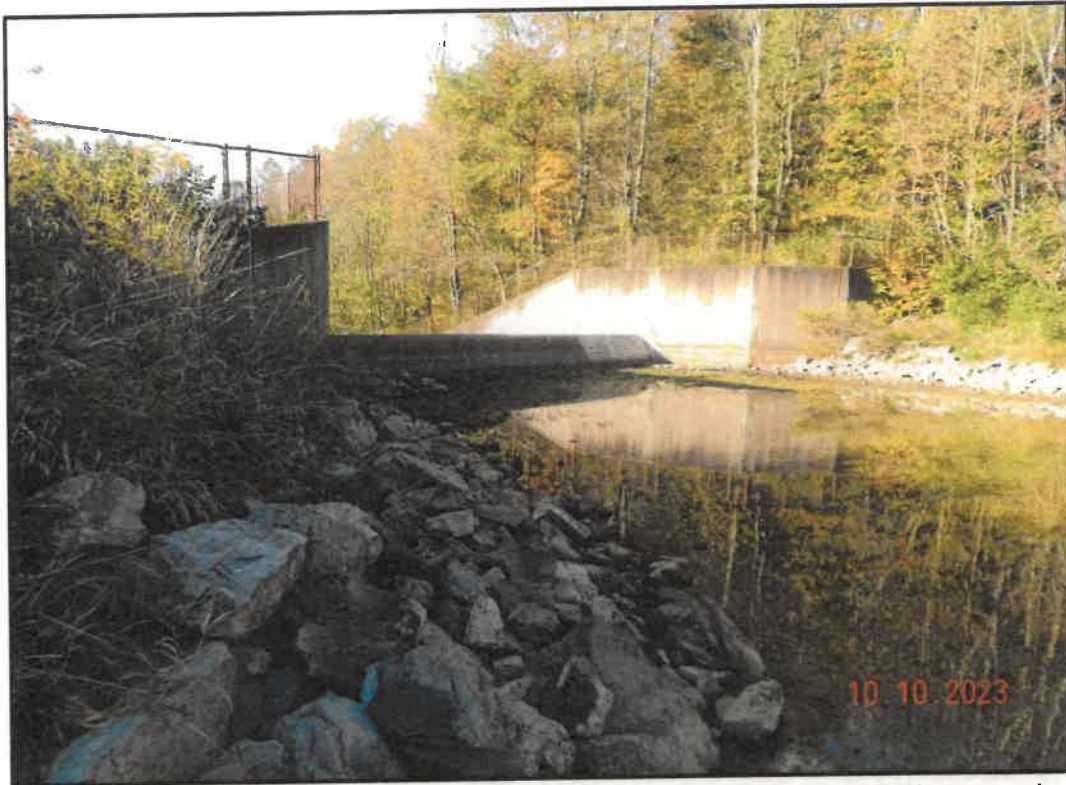
Photo 9: View of Spillway Approach Channel, Note underbrush that needs cut

2. As identified on the Sketch Plan, the areas on the downstream embankment with brush / woody growth needs cut. Also, areas along the upstream embankment slope are overgrown and should be cut. An area along the left abutment and at the outlet headwall also needs cut. See the Sketch Plan and Photos 9, 24, and 25.

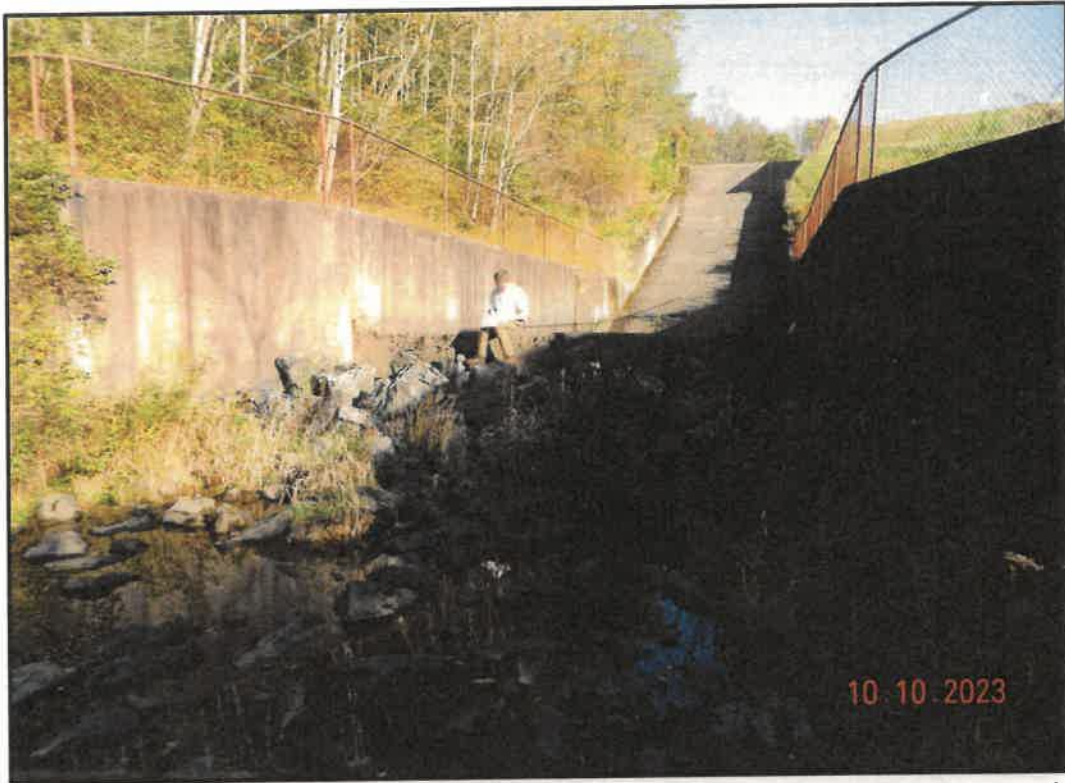
Photo 15: View of Stilling Basin Wall and Weir. Note corroded ends of pipes passing through stilling basin wall

5. The inlet ends of the corrugated steel pipes through the stilling basin wall should be cleared of silt and debris. Consideration should be given to repairing the corroded ends of these pipes or the pipes' outright replacement. See Photos 15 and 26.

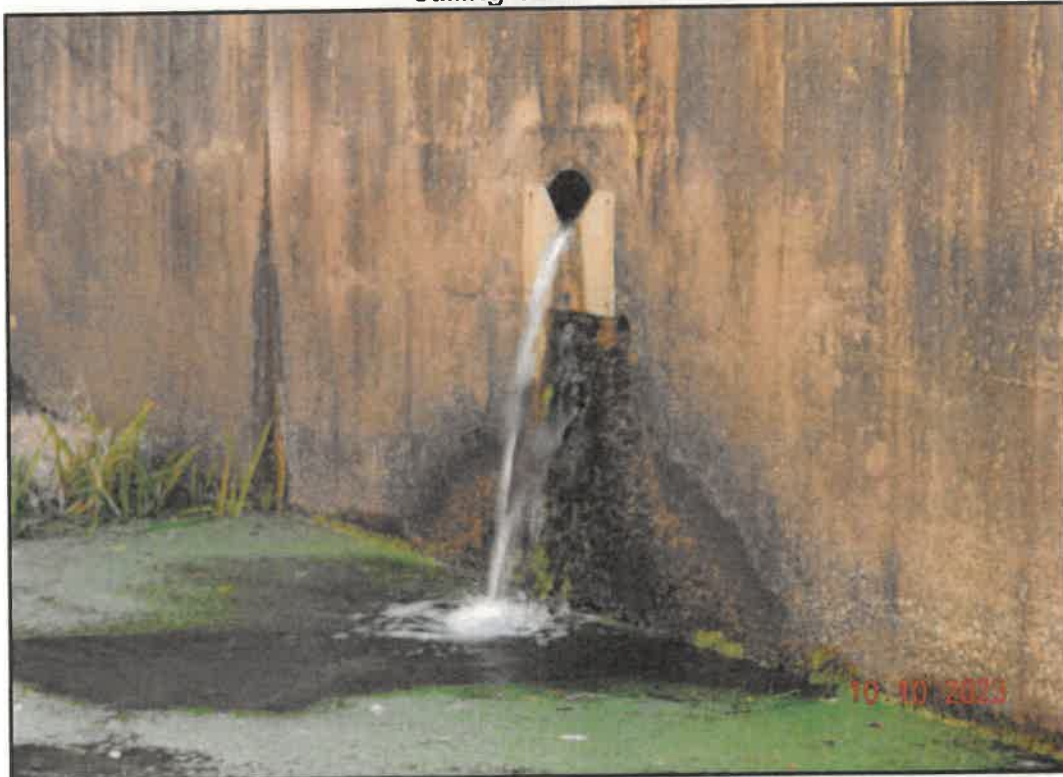
1. The dam's foundation drain discharges over a weir plate in the eastern spillway wall and into the stilling basin. Over the past few years, seepage has been flowing behind the weir plate, eroding the concrete the plate is fastened to at an increasing rate. The seepage flowing behind their weir plate has eroded the concrete to the point where a significant portion of the seepage flows behind the weir plate, only worsening the erosion. This issue should be rectified. In the short term, the weir plate should be removed to minimize concrete deterioration behind it. (See Photo 16)

Photo 16: View of Weired Seepage Outlet through Eastern Spillway Wall. (Note, water seeping behind and under weir plate)

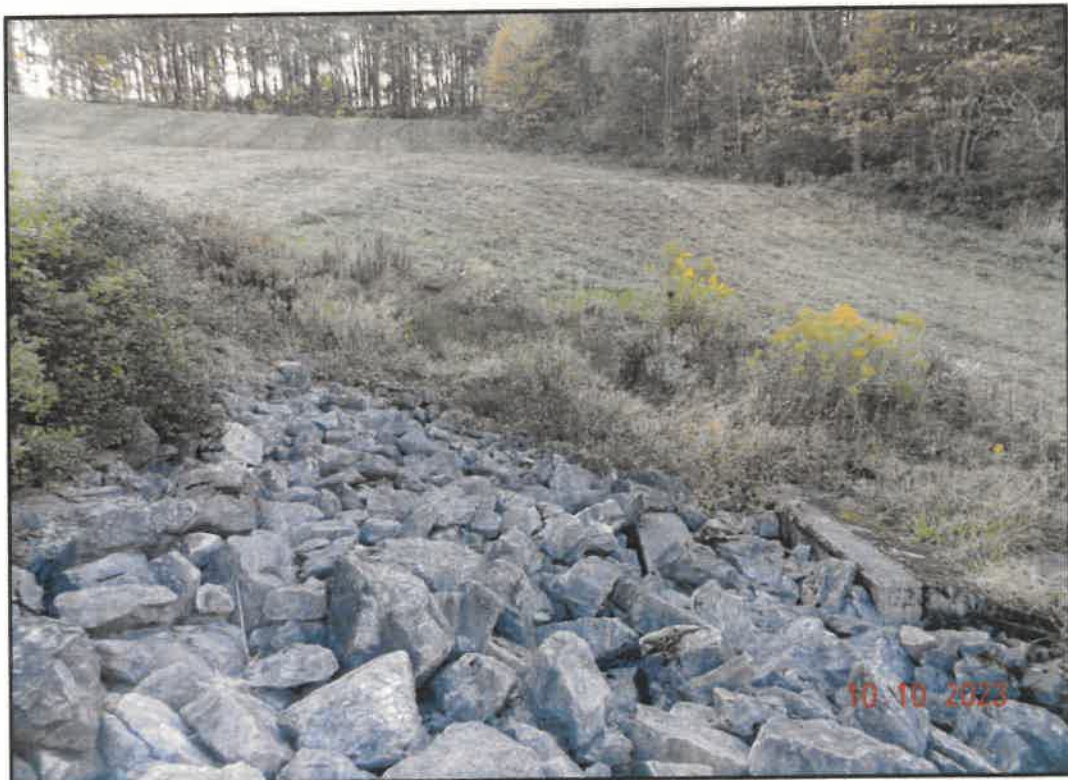
Photo 18: View of "Wet Area" Adjacent to Junction Box (dry this year)

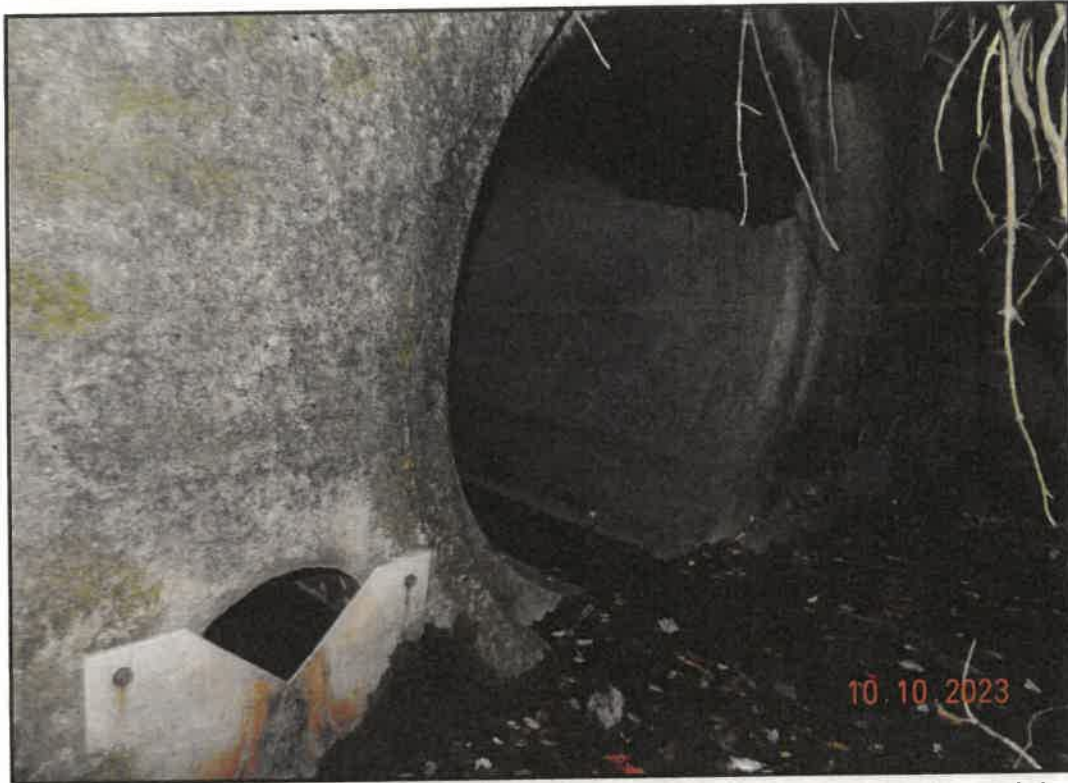
Photo 19: View of Reservoir Drain Outlet. Note, No Flow in Either Weir.

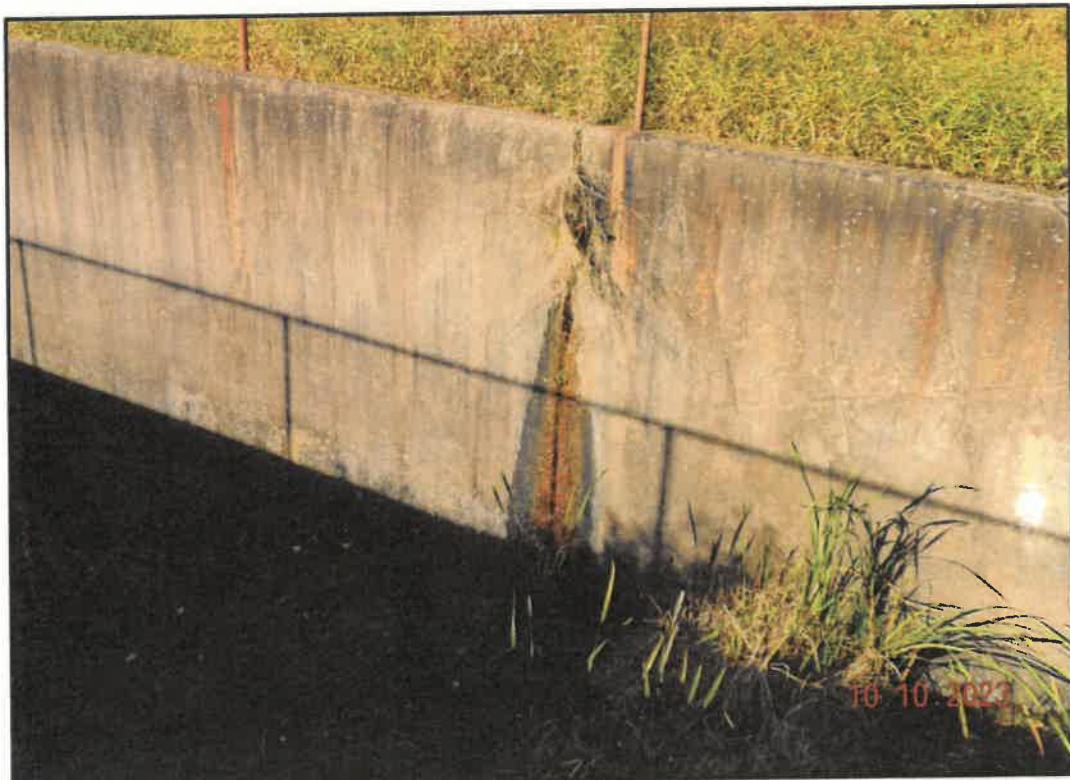
Photo 20: View of Seepage area on Western Wall Above Stilling Basin

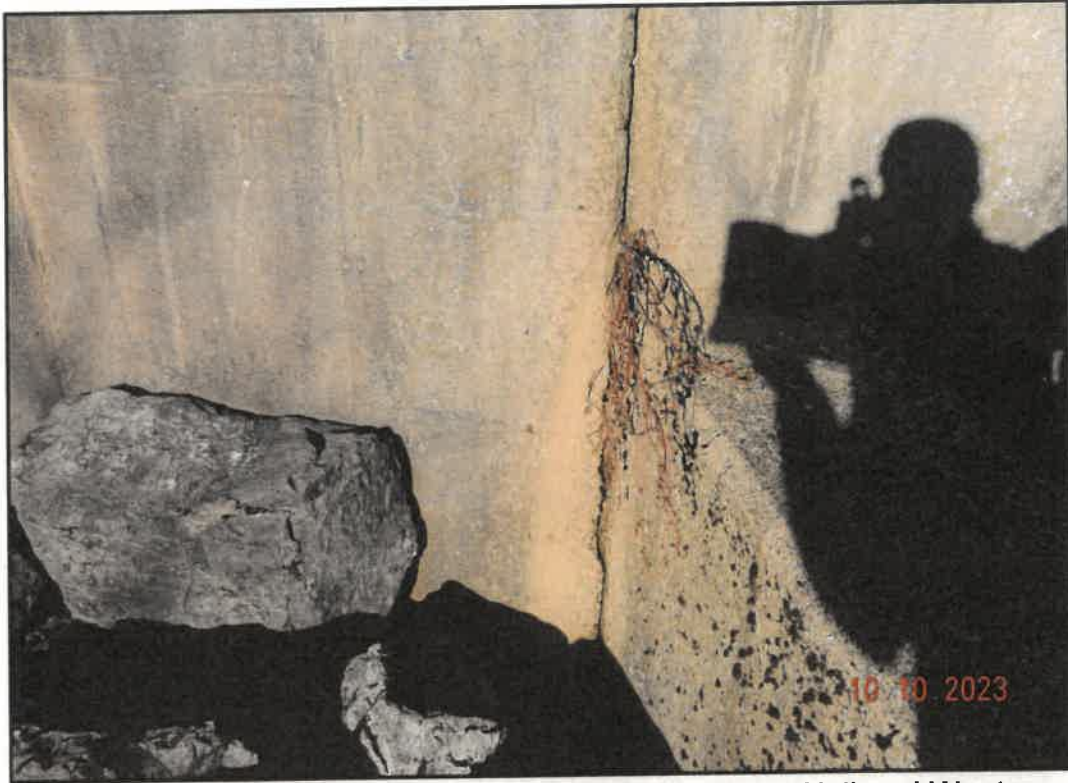
Photo 21: View of Seepage area between Stilling Basin Weir Wall and Western Abutment

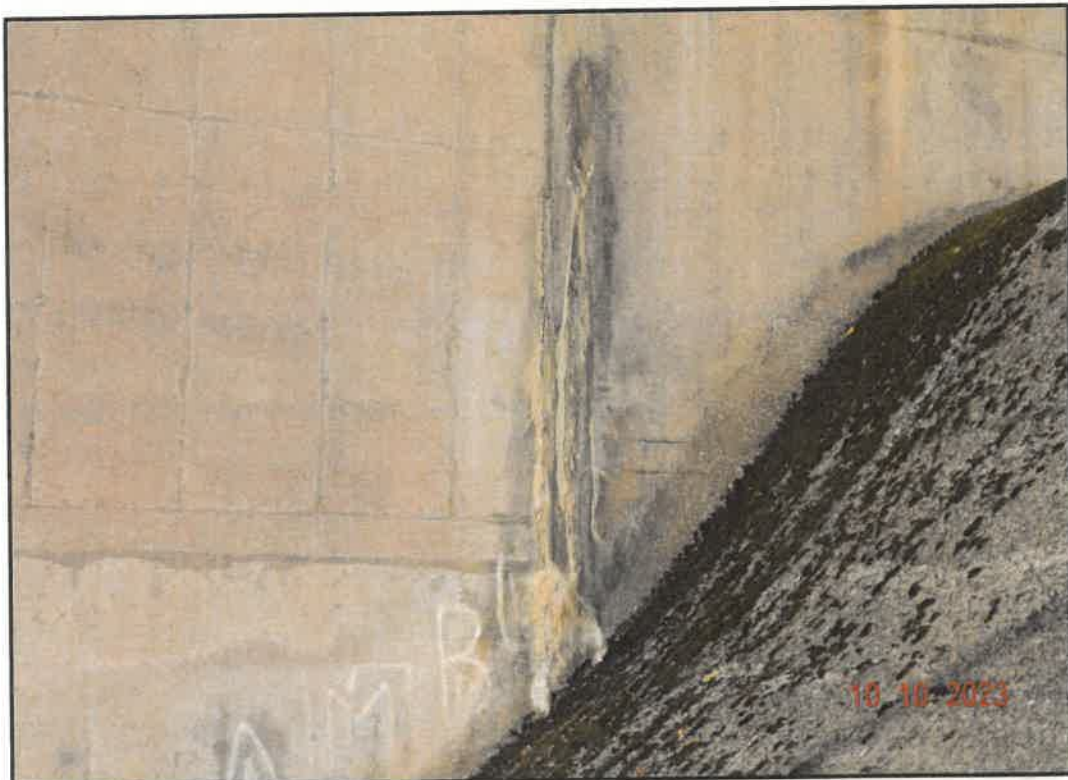
Photo 22: View of Seepage through Western Spillway Wall approx. 10' below Weir. Note that most of the Discharge is not in the Wall Joint. (note. no liquid seepage was observed, only

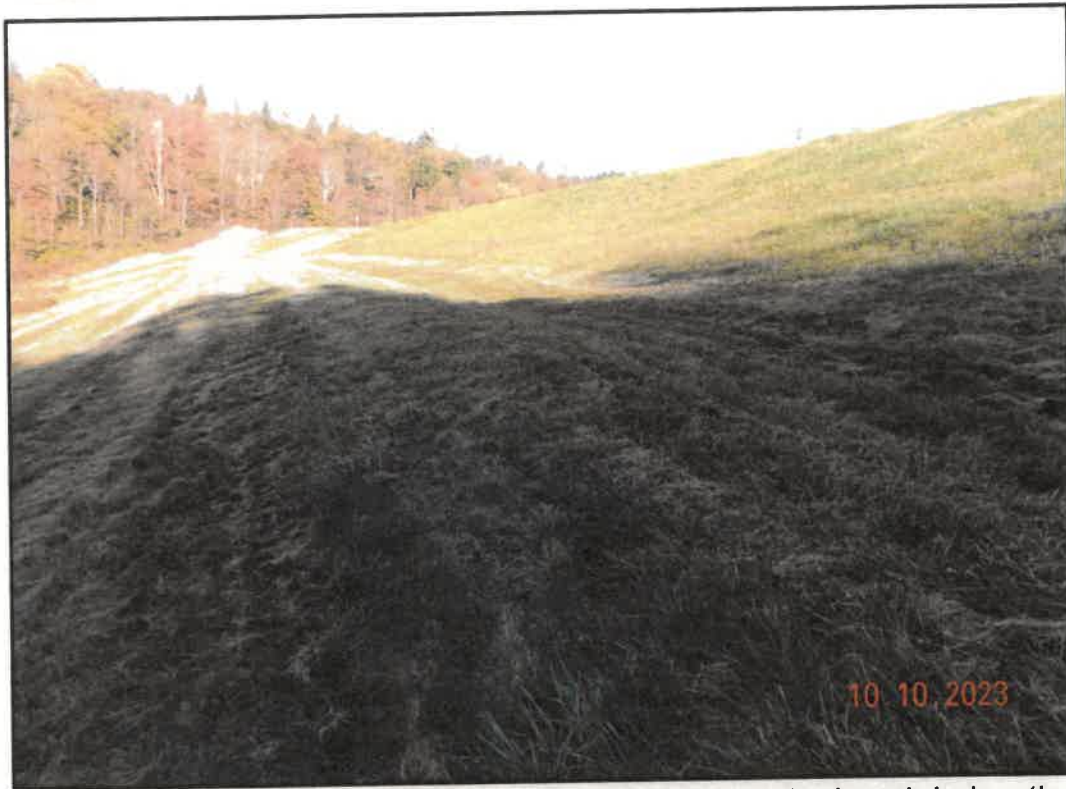
Photo 23: View of Typically Wet Area (dry this year) on the 1st bench below the Dam's Crest. This view is typical for the majority of the crest.

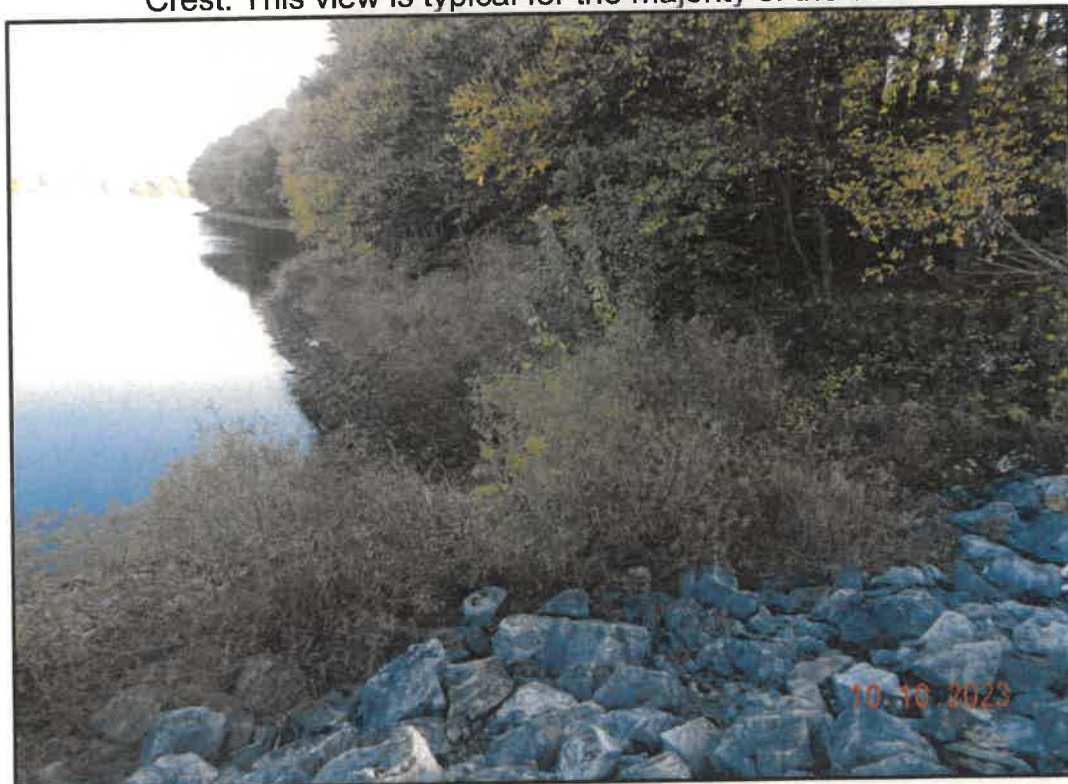
Photo 24: View of Overgrown Brush along Southeastern Upstream Embankment.

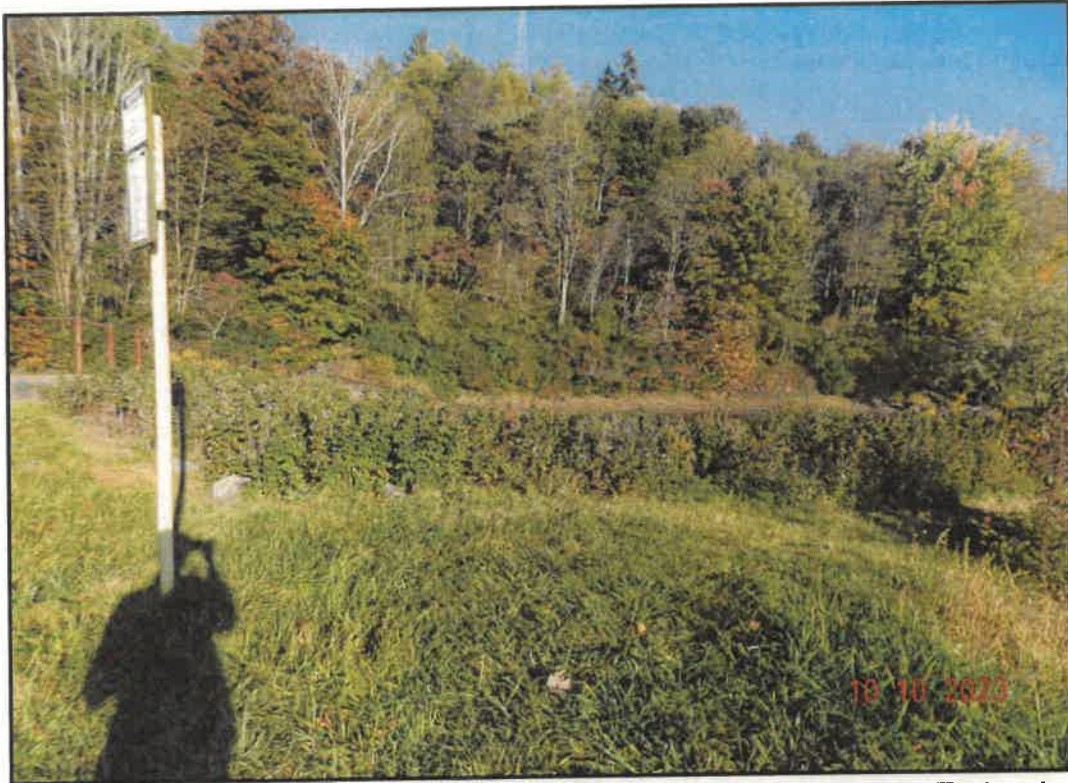
Photo 25: View of Overgrown Brush along Northwestern Upstream Embankment.

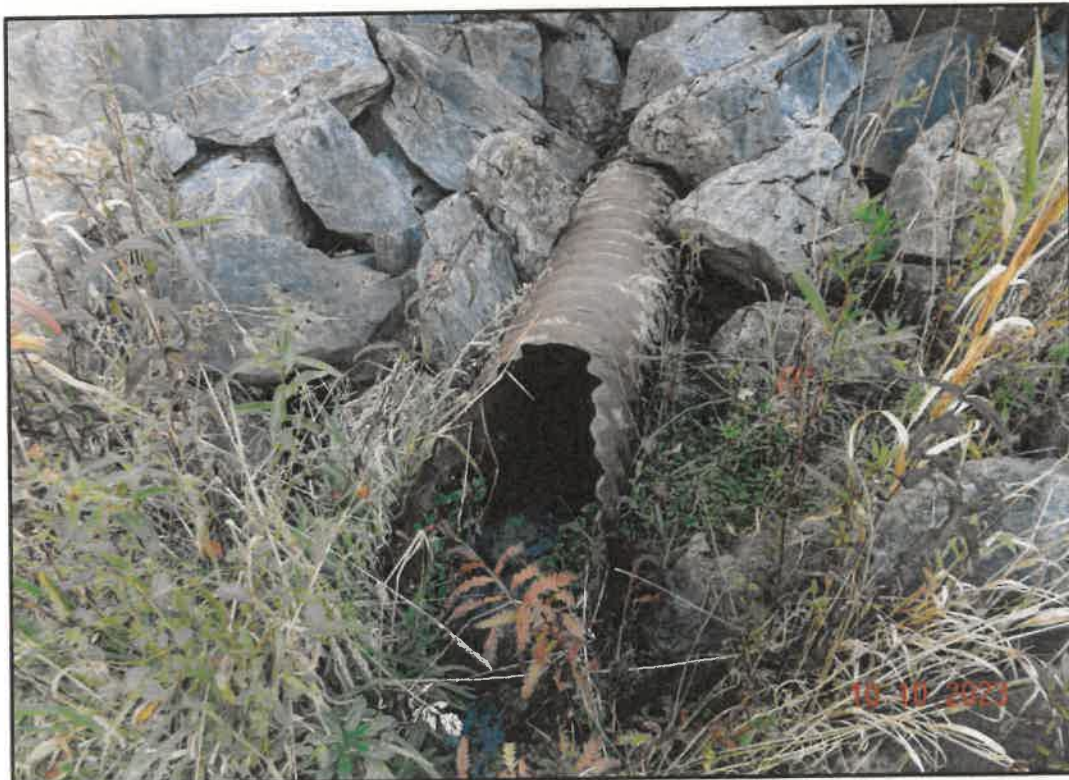
Photo 26: Corroded 15" CMP passing through stilling basin weir wall.

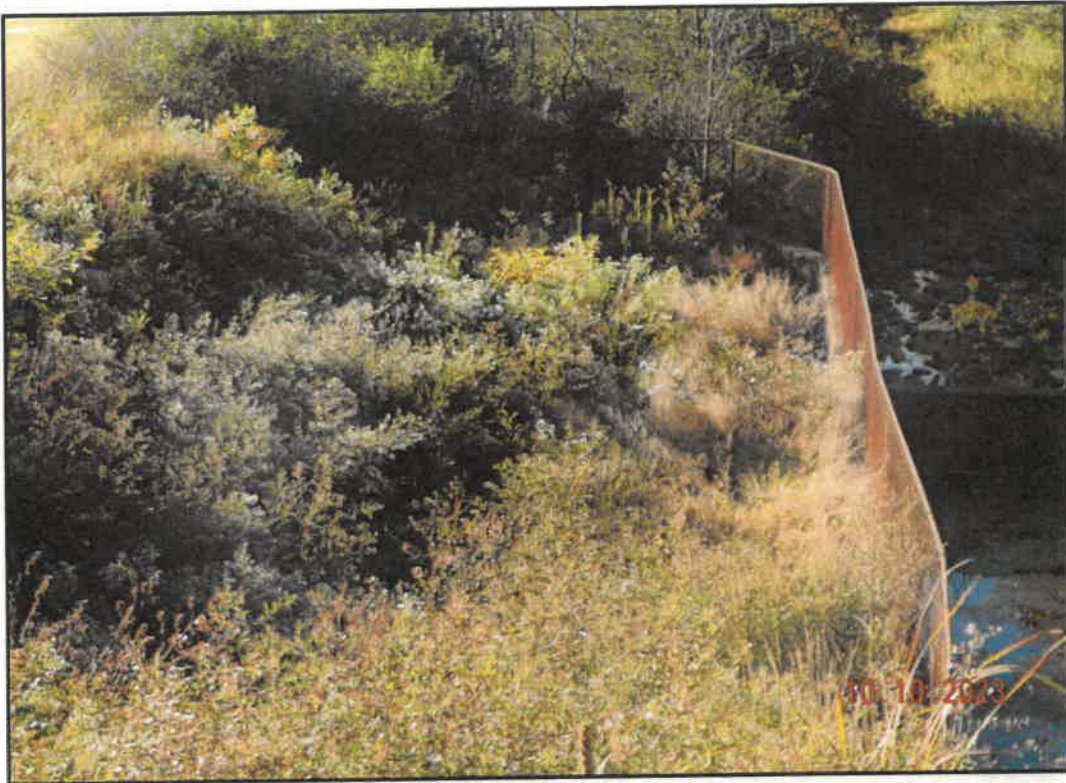
4. Two new wet areas were identified during the 2022 inspection. Both areas east (see photos 27 & 28) and west of the stilling basin (see photo 31) portion of the spillway were notably wet with visible flow. A "swale" of wetness also extended parallel to the western spillway wall, about half the length of the spillway. Please note, these areas were likely wet during past inspections but the thick brush in both areas prevented any thorough observations from being made. (See Sketch Plan).

Photo 27: View of Wet Area behind Eastern Abutment Wall at Stilling Basin

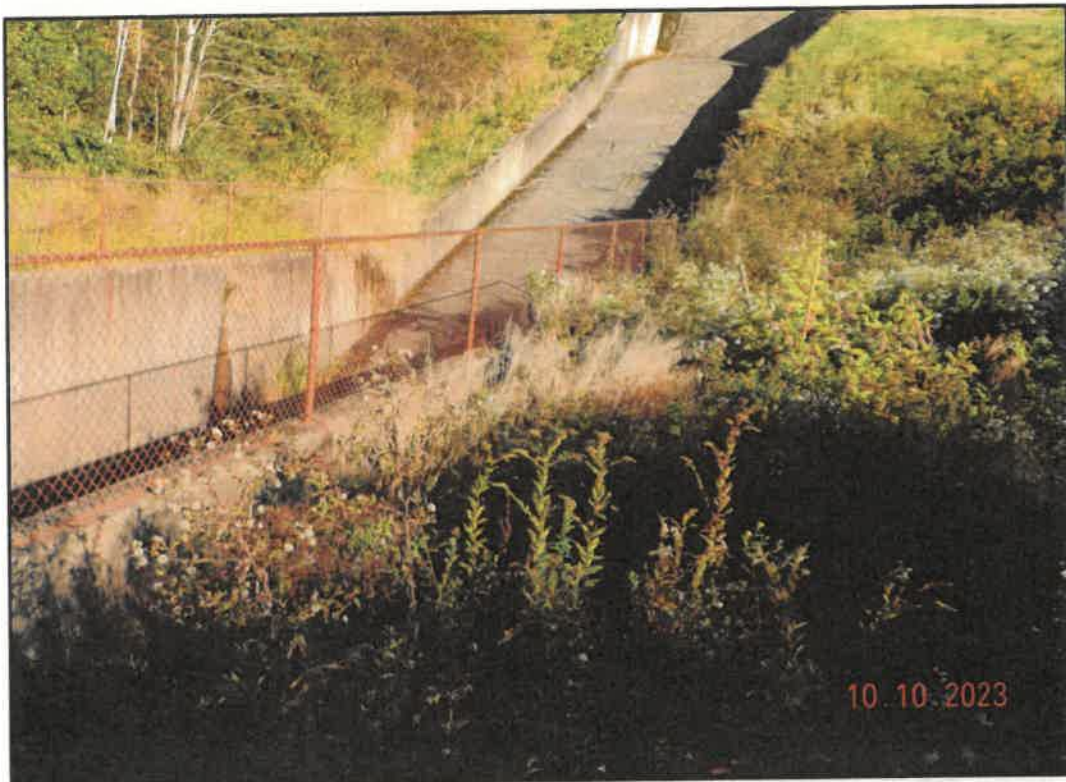
Photo 28: View of Wet Area behind Eastern Abutment Wall at Stilling Basin

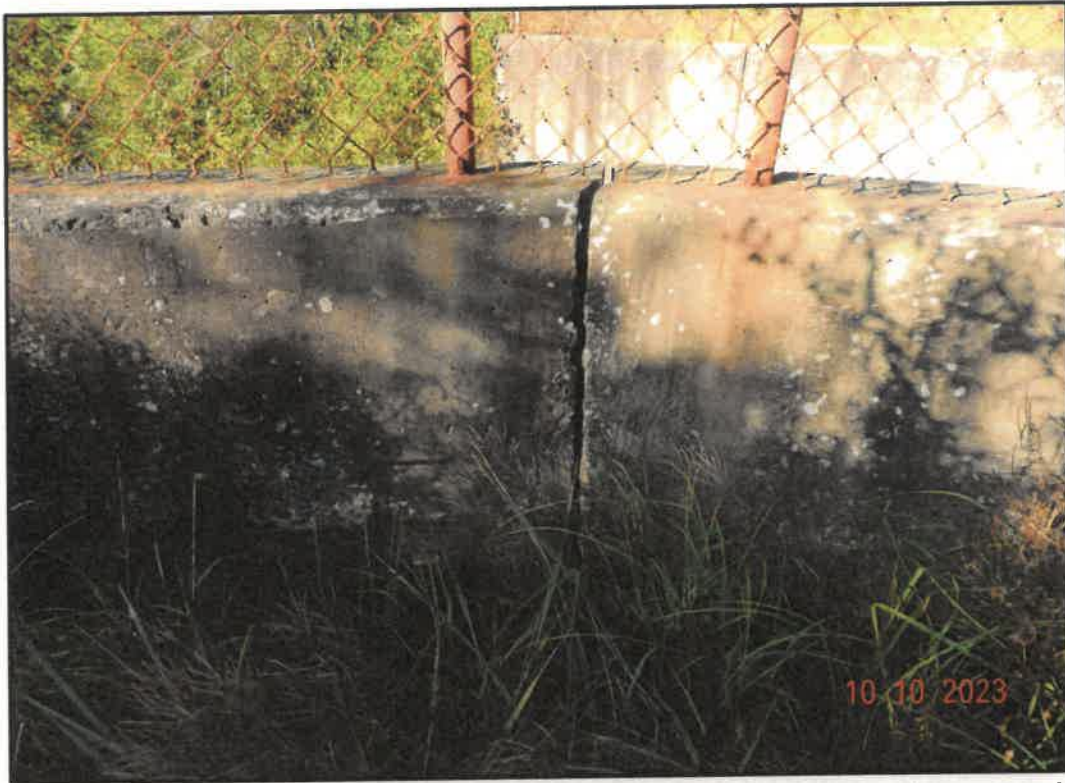
9. The concrete joint where the eastern spillway wall meets the stilling basin overflow spillway was notably separated this year. Some portion (approx. 5-10 gpm) of the eastern spillway wall wet area was flowing through this separation. Additionally, the next joint down from this separation was also beginning to separate, although less severely. (See Sketch Plan.)

Photo 29: Joint with Active Flow of Water in Eastern Abutment Wall adjacent to Wet Area
(Back Face View)

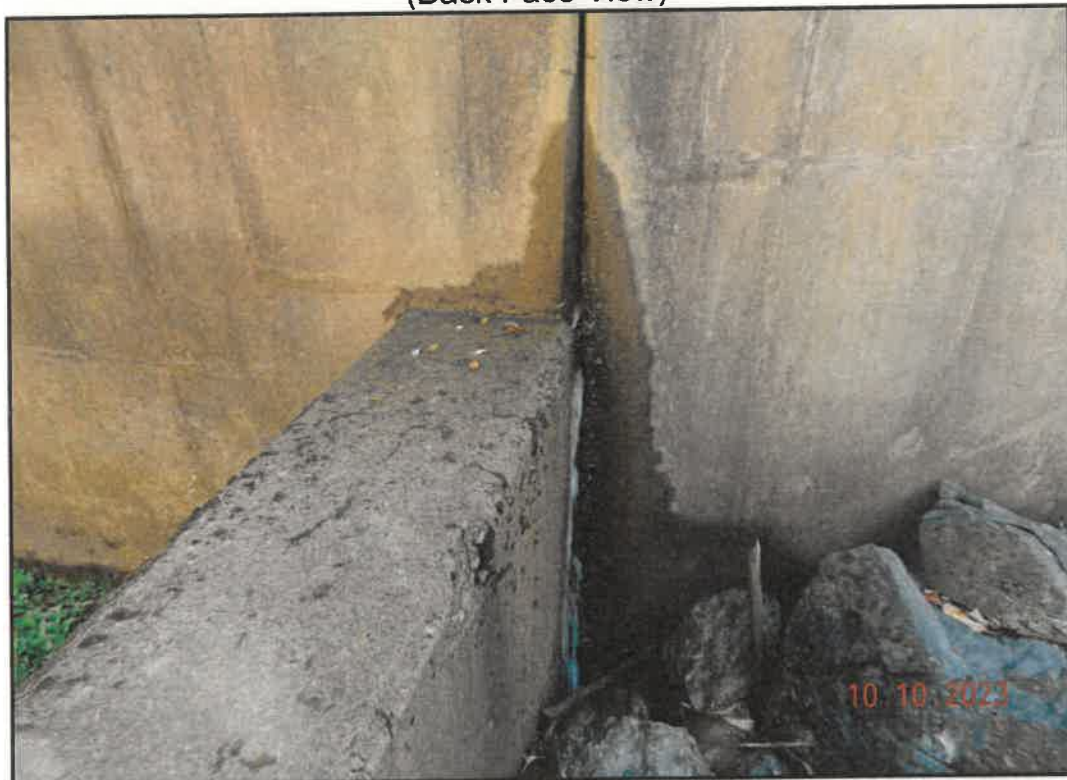
Photo 30: Joint with Active Flow of Water in Eastern Abutment Wall adjacent to Wet Area
(Front Face View)

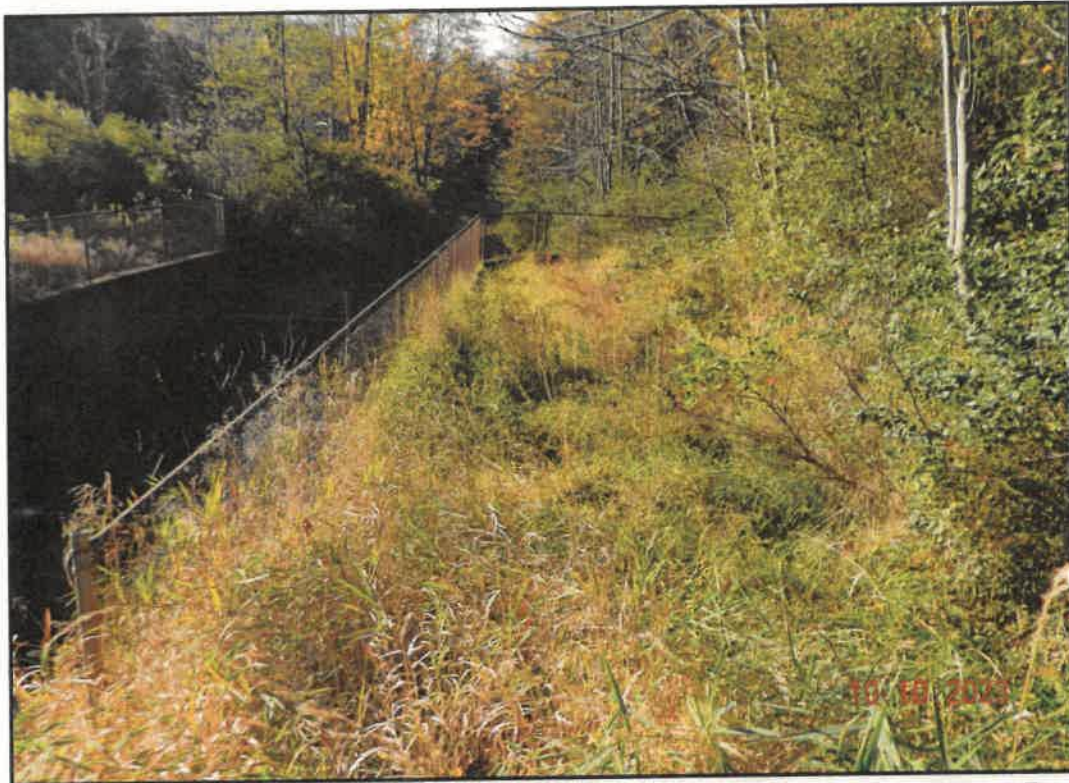
Photo 31: View of Wet Area behind Western Abutment Wall at Stilling Basin

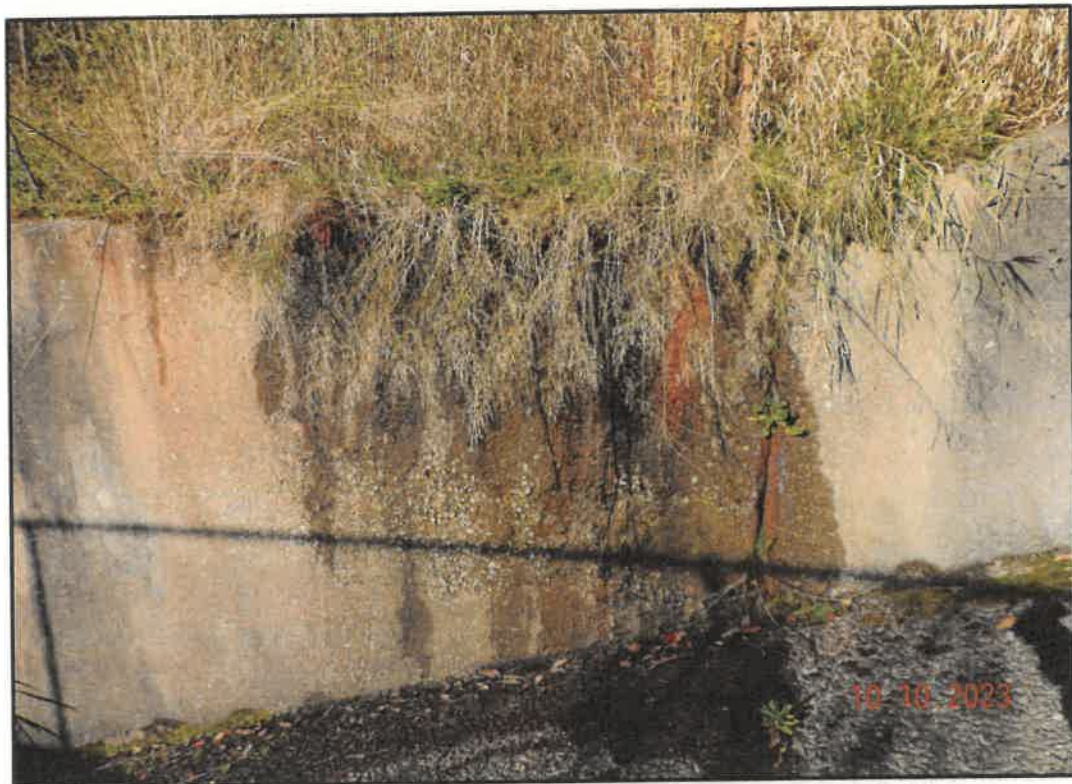
Photo 32: View of Seepage Area on Western Wall Above Stilling Basin

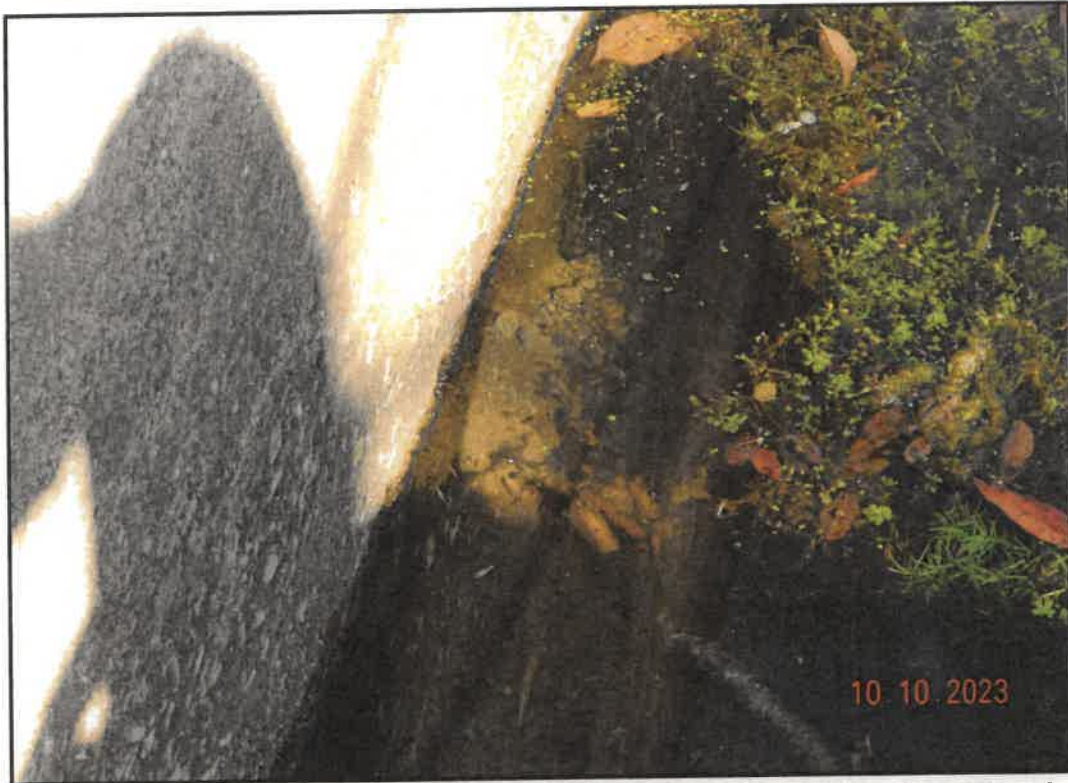
10. During the 2022 inspection, a small pipe opening was identified on the western spillway wall, in the stilling basin, slightly below the basin's normal pool. In 2022, around 1-2 CF of clean fill (likely 2A stone) was present at the discharge of the pipe, likely indicative of the pipe which leads to this outlet being crushed. Around 2-3 CF of fill was present this year, to the point that the pipe opening is mostly closed. Since the pipe opening is now essentially closed, there should not be much, if any, increase in stone volume next year, however this pipe should continue to be monitored. Note, the original construction drawings are unclear on the purpose or nature of this pipe. (See Photo 33).

Photo 33: Backfill at Base of Weepole on Western Abutment Wall (Possible Collapsed Pipe)

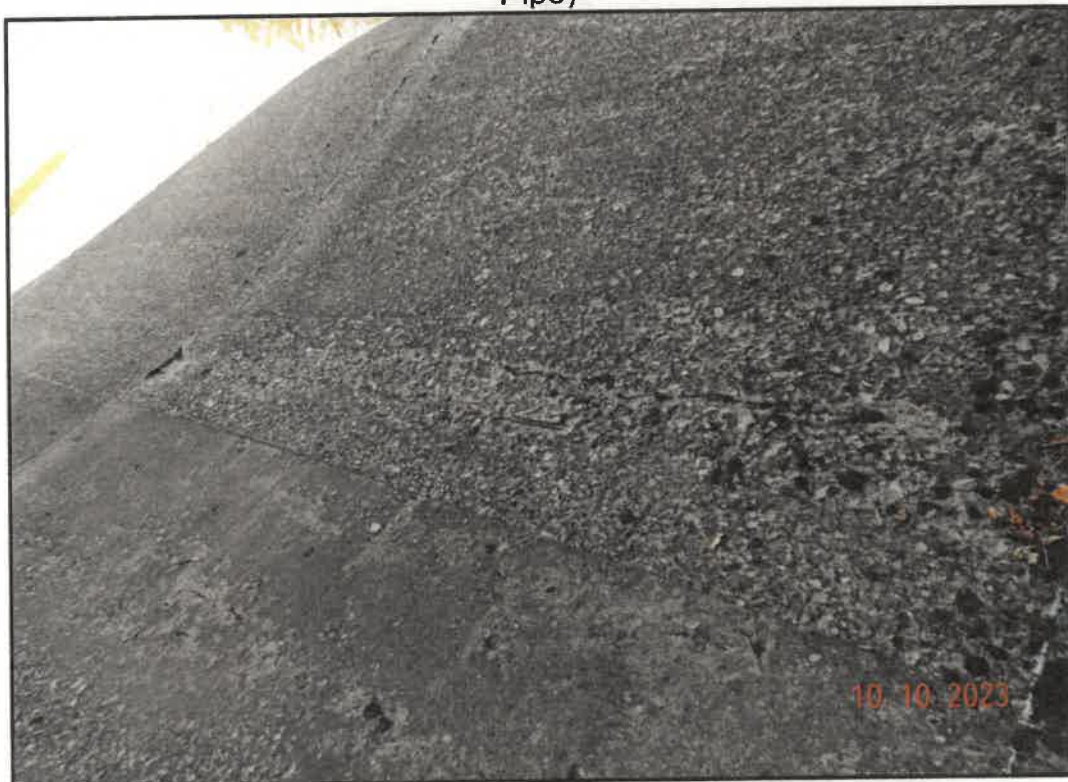
11. Small portions of exposed rebar were identified on the downstream face of the spillway ogee wall.
12. The primary closure valve should be operated prior to next year's inspection.

Photo 34: Exposed Reinforcement Bar in Face of Ogee

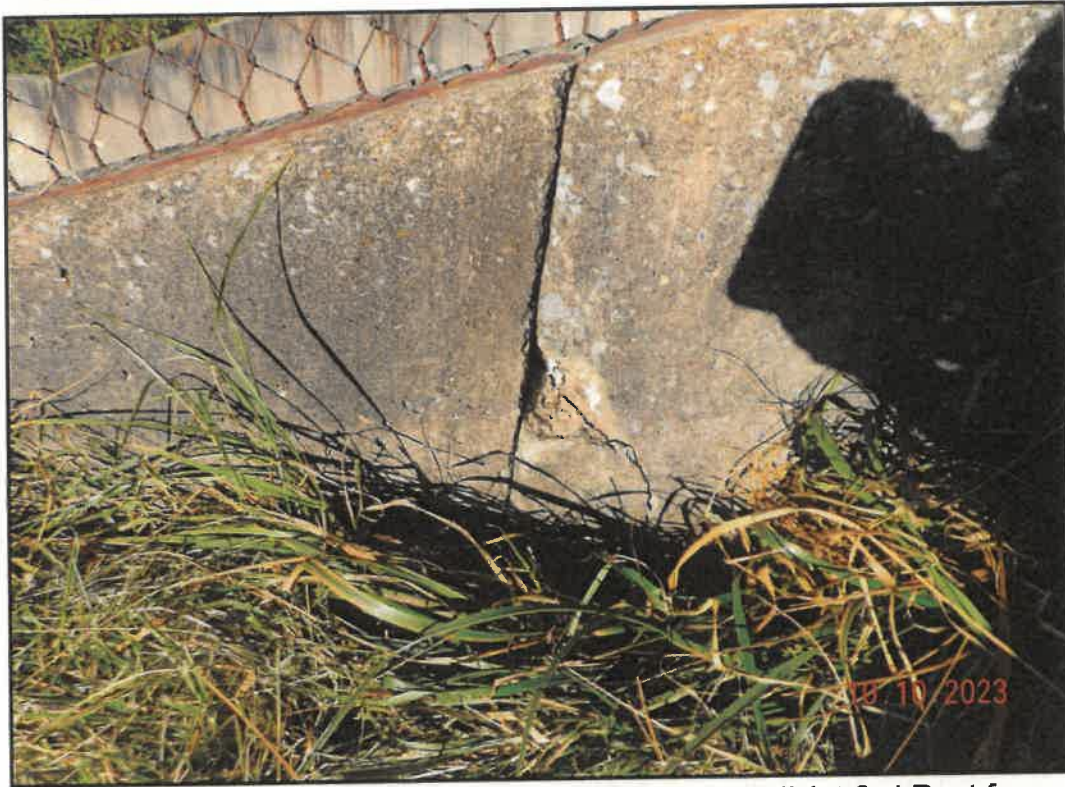
Photo 35: Spalling and Cracking Concrete on Eastern Wall (at 3rd Post from Crest)

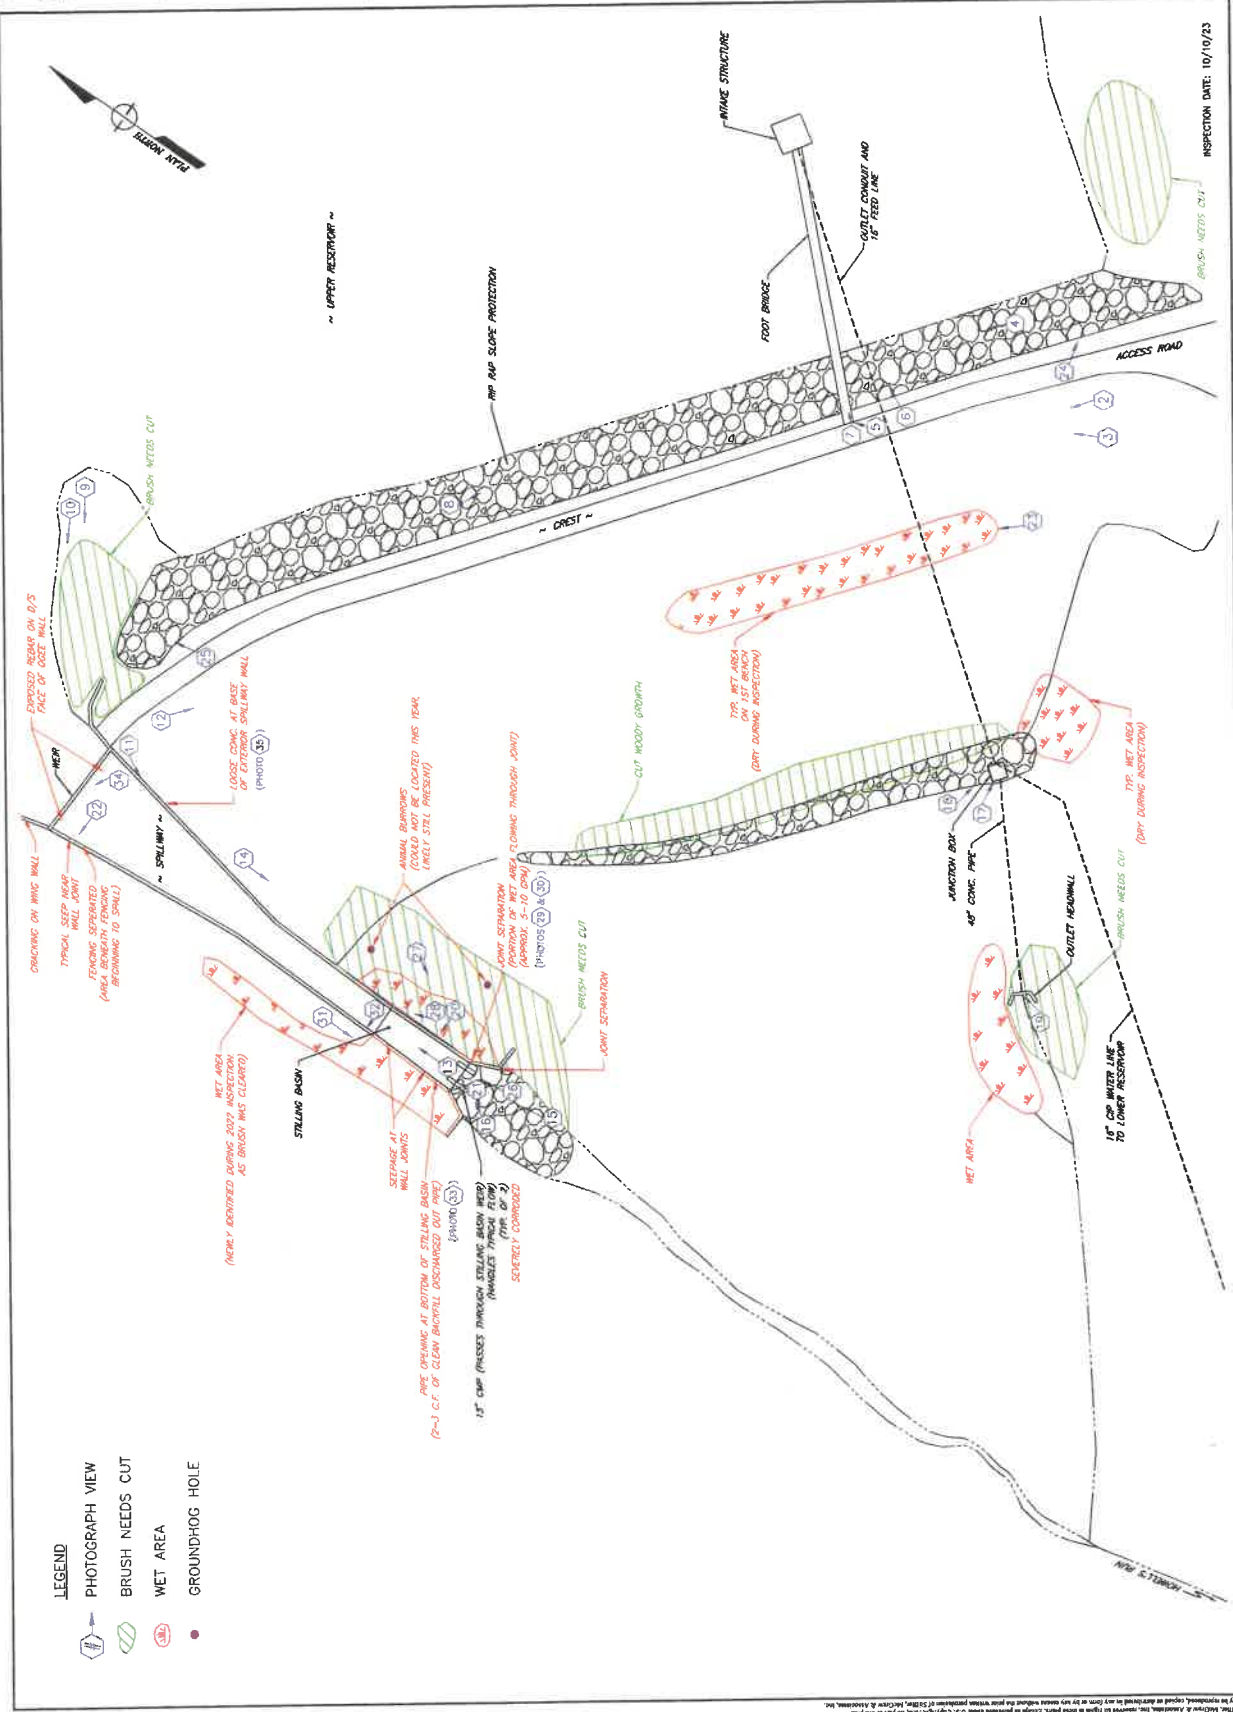
**DAM INSPECTION
SKETCH PLAN**

3. During the 2022 inspection, two notable animal burrows were observed at the lower portion of the downstream face, east of the spillway wall. During the 2023 inspection these burrows could not be located, but it is our suspicion that they are still present but could not be located due to high brush in these areas. These animal burrows should be located and appropriately filled to prevent any further damage. See Sketch Plan.

6. One of the three typically wet areas along the downstream embankment were wet this year. These areas should continue to be periodically monitored. See sketch plan for specifics.
